AGENDA
CHARTER TOWNSHIP OF MERIDIAN
TOWNSHIP BOARD – SPECIAL MEETING
April 16, 2019 6:00 pm

To: Township Board Members
**From: Derek N. Perry, Assistant Township Manager
Director of Public Works & Engineering**
Date: April 16, 2019
Re: Local Street Improvement Program & Funding

To assist with our decision making process, we contracted with DLZ to inspect and prepare a report of their findings on the current condition of the camelback bridge, the cost to make the necessary repairs to serve as a pedestrian bridge and potential future costs to maintain it.

OKEMOS ROAD BRIDGE
IMPROVEMENT PROJECT
ENVIRONMENTAL ASSESSMENT

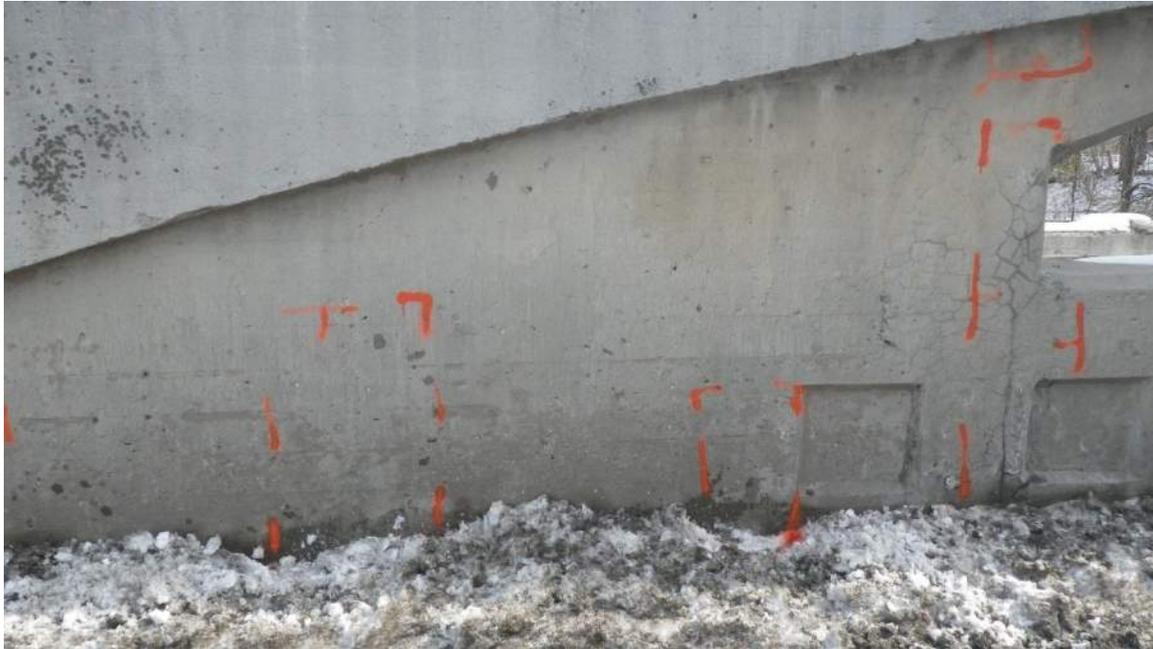
areas of delaminated concrete were found on the inside and outside of both arches, including areas on the concrete columns on the west arch (**Photos 3, 4 and 5**). The arches, above the deck surface level, are in fair condition.

Photograph No. 3
Area on West Side of East Arch Near North End with Delaminated Concrete

- Removal and replacement of the existing sidewalk fascia area below the existing sidewalk railing
 - Removal and replacement of the existing railings on top of the abutment walls in the northwest and southwest quadrants
 - Chipping and patching of the deteriorated concrete areas on the arches above the deck level, and on the stringers, below the deck level
-

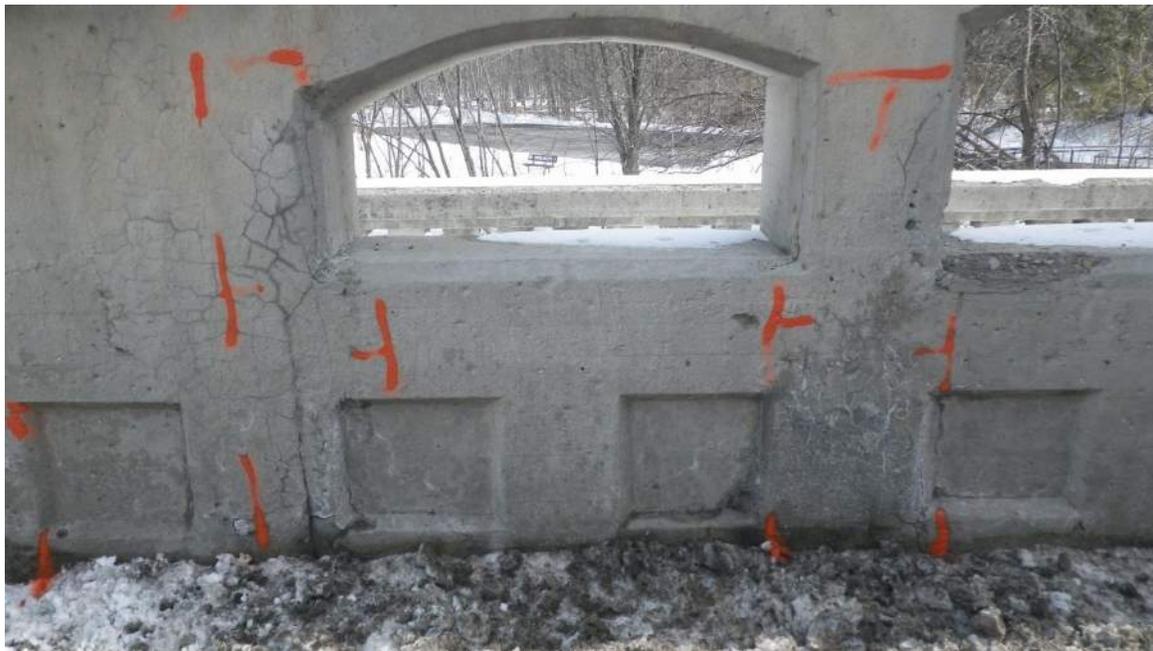
Photograph No. 4
Area on West Side of East Arch Near North End with Delaminated Concrete

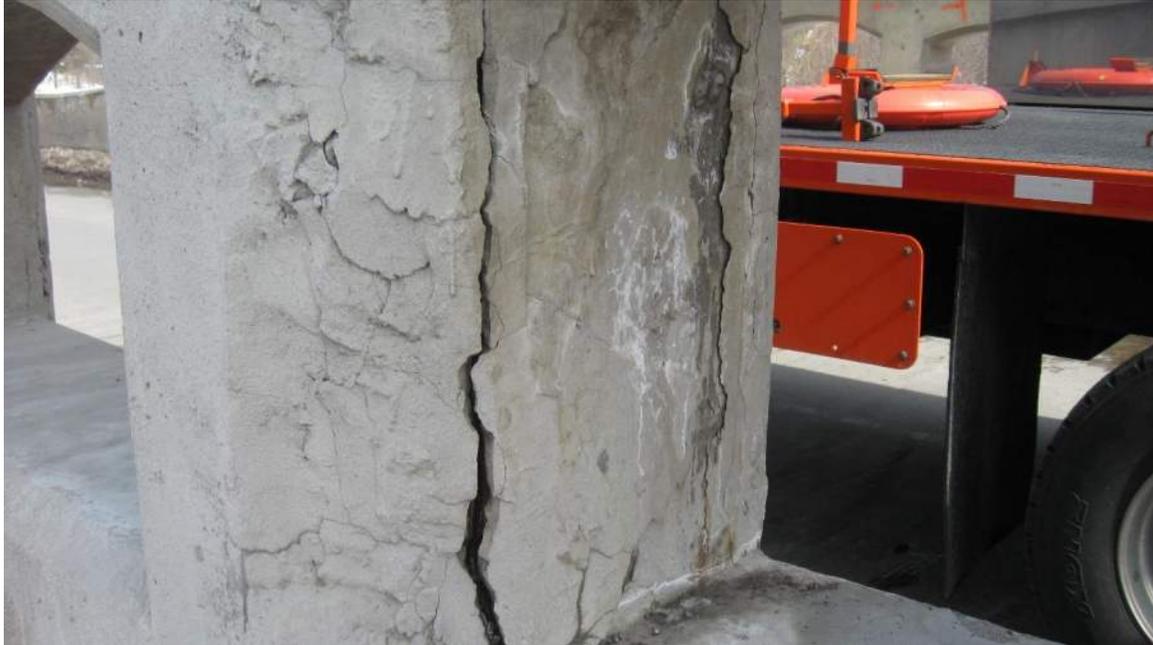
Photograph No. 5

West and South Faces of West Arch Column Near North End with Cracked and Delaminated Concrete Patch

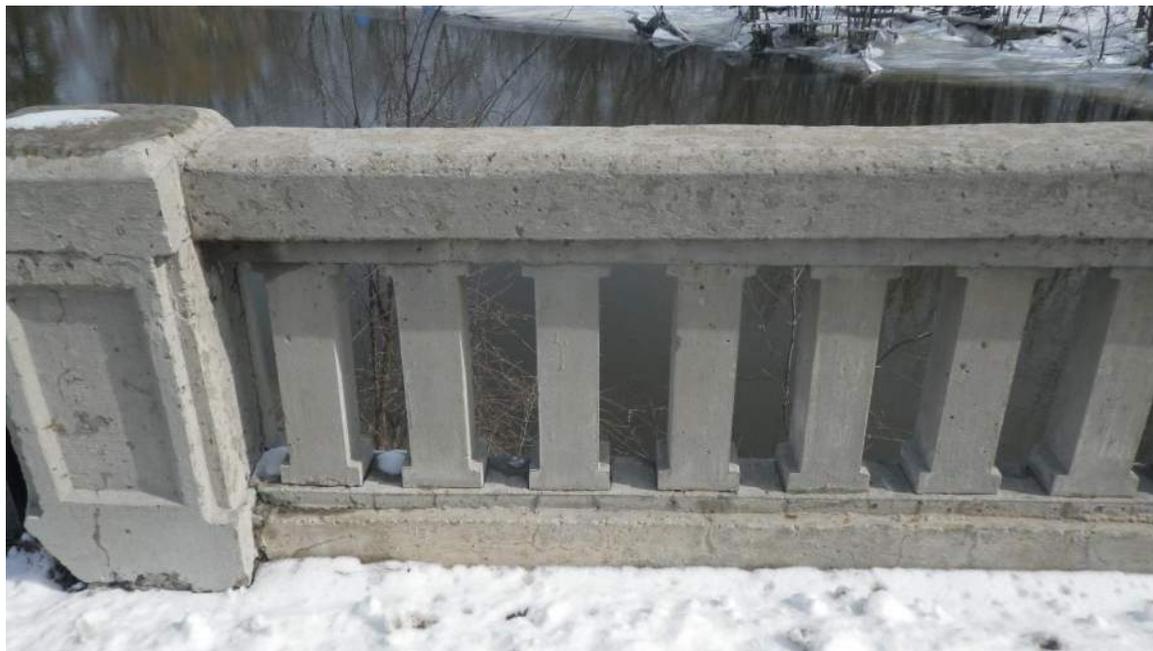
Photograph No. 6

Portions of East Sidewalk Railing, Interior Face, in Good/Fair Condition

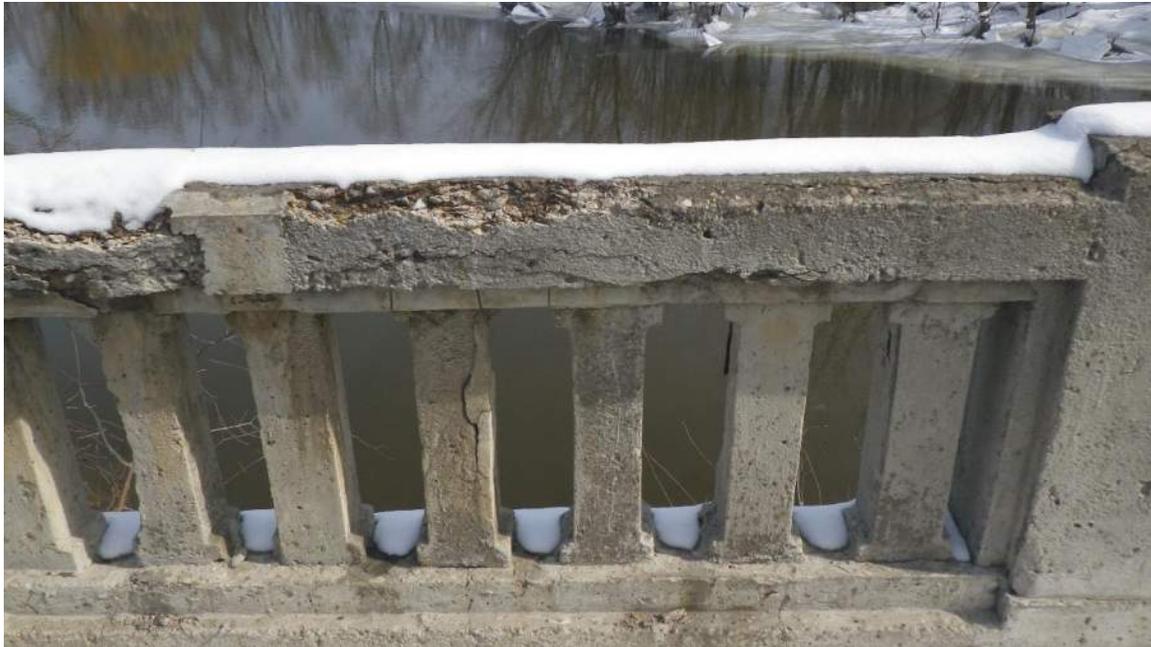
The railings along the east edge of the sidewalk and on top of the return walls on the west side of the structure consist of concrete, horizontal top and bottom rails and vertical spindles. Portions of these railing sections are in good/fair condition (**Photo 6**), while most of the railing sections are in fair/poor condition or highly deteriorated condition (**Photos 7, 8, 12 through 14**).

Photograph No. 7
Portions of East Sidewalk Railing, Interior Face, in Fair/Poor Condition

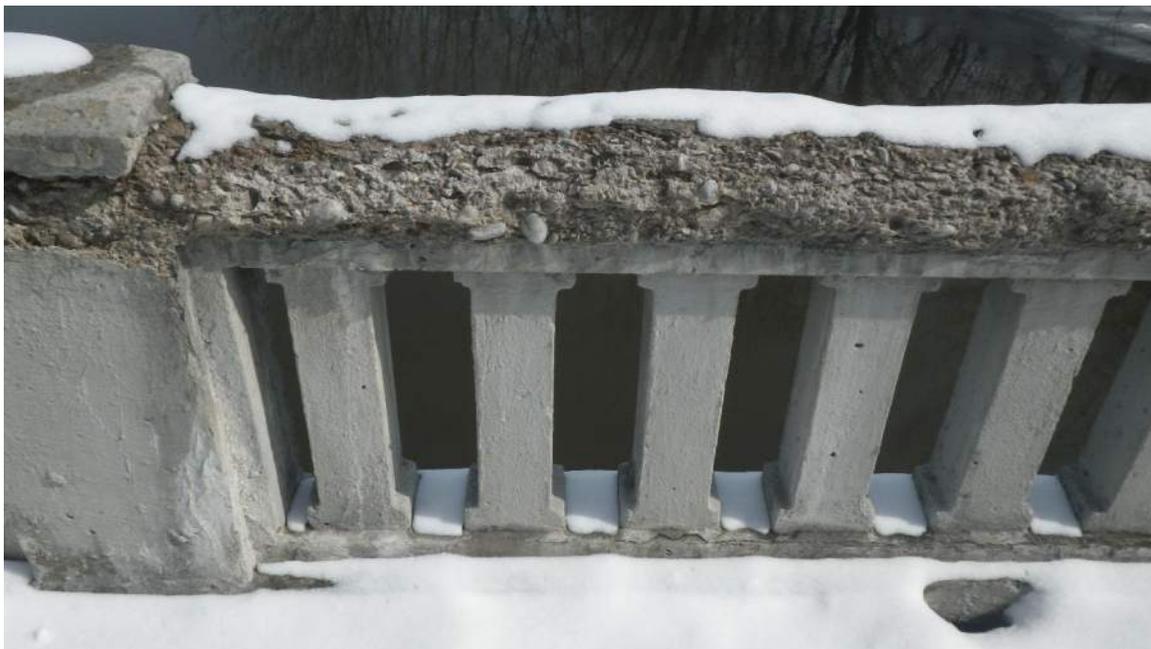
Photograph No. 8
Portions of East Sidewalk Railing, Interior Face, in Poor Condition with Advanced Deterioration

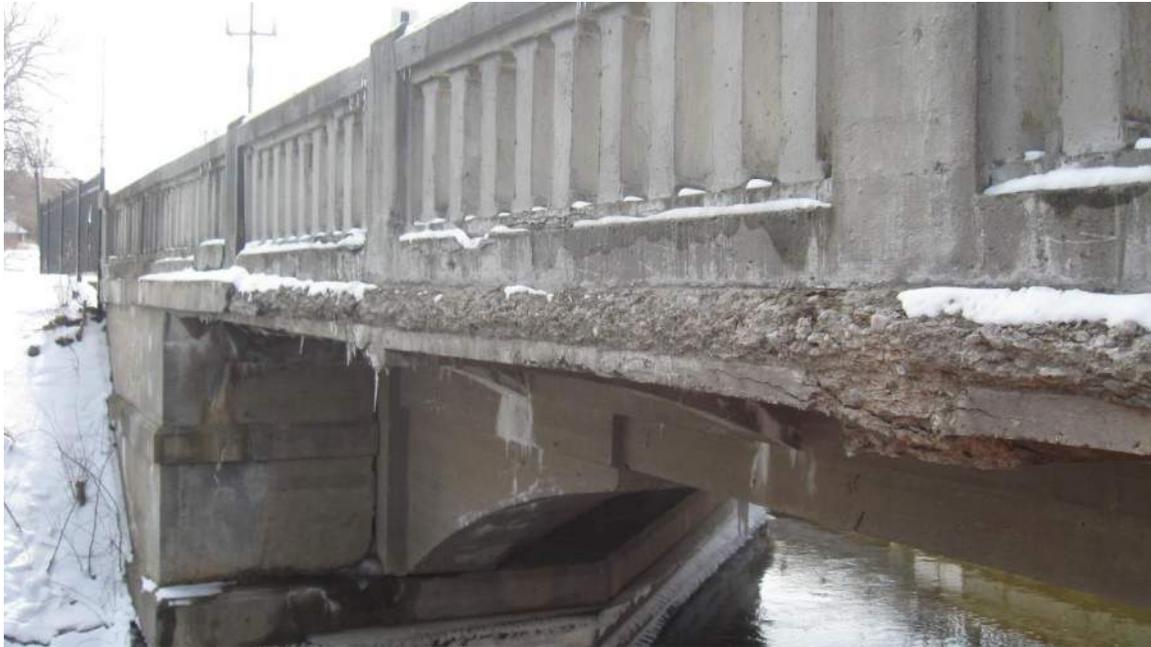
The top sidewalk surface was covered with snow and could not be inspected. From the most recent bridge inspection report, there are numerous hairline transverse and longitudinal cracks present. The bottom of the sidewalk has numerous areas of delaminated and spalled concrete, with exposed and corroded reinforcing steel (**Photos 21 and 22**). The sidewalk fascia is highly deteriorated, with cracked, spalled, delaminated and highly deteriorated concrete present along much of its length (**Photos 9, 10 and 11**).

Photograph No. 9
Elevation of East Sidewalk Fascia with Heavy Spalling - South Portion

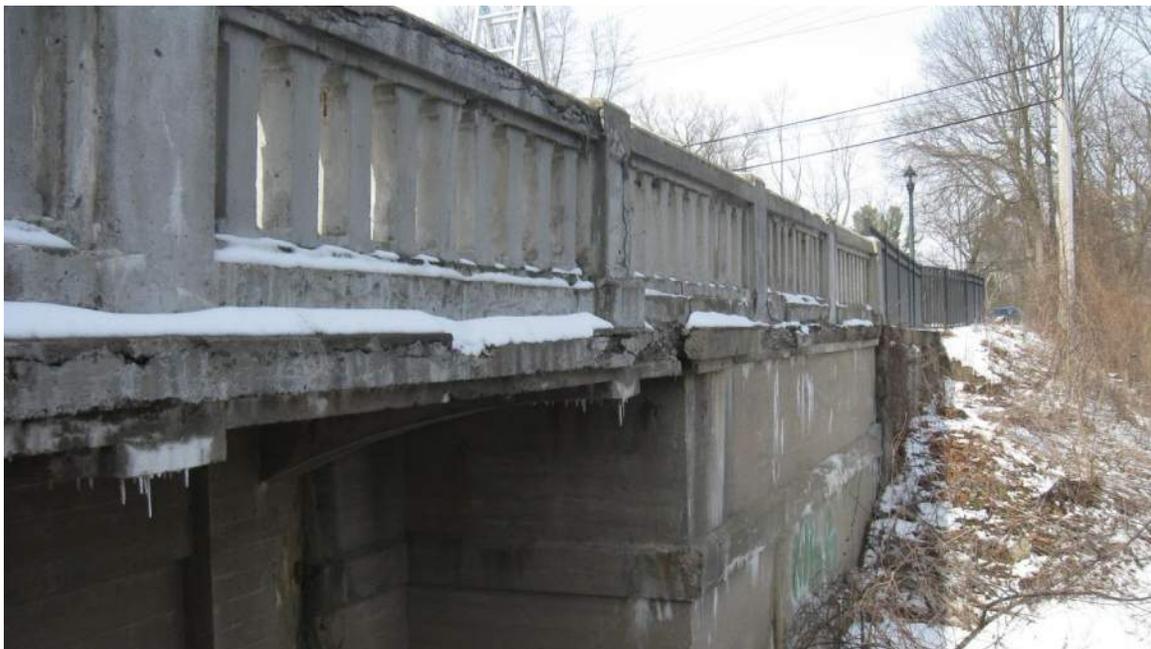
Photograph No. 10
Elevation of East Sidewalk Fascia with Heavy Spalling - North Portion

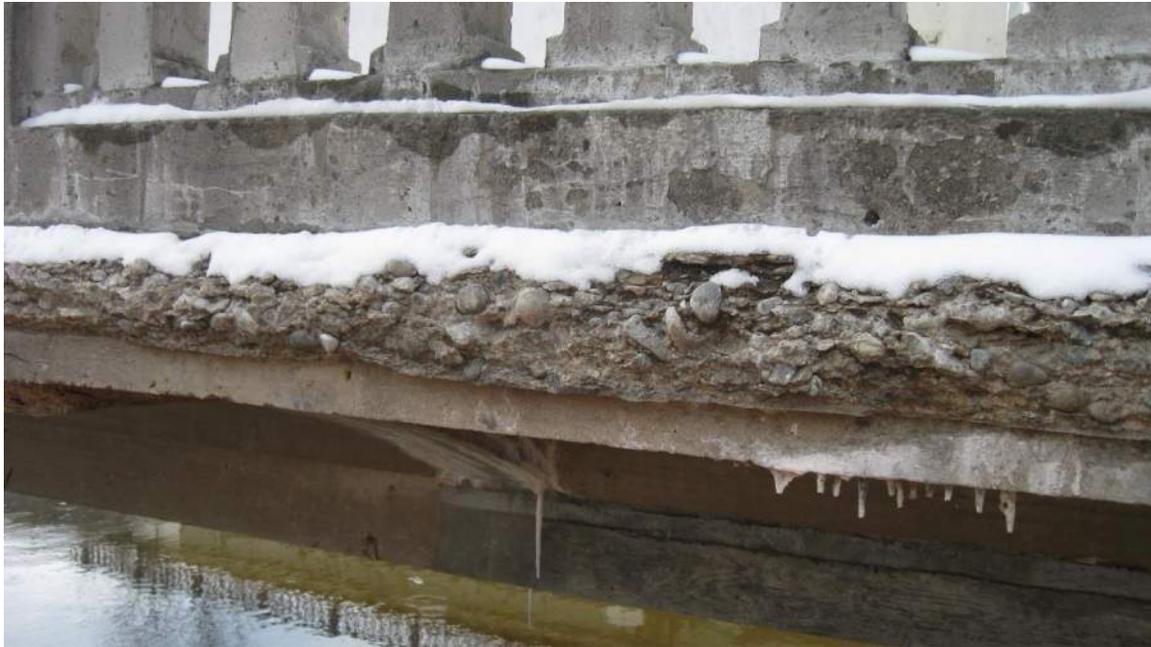
Photograph No. 11

Close-up of East Sidewalk Fascia with Advanced Deterioration

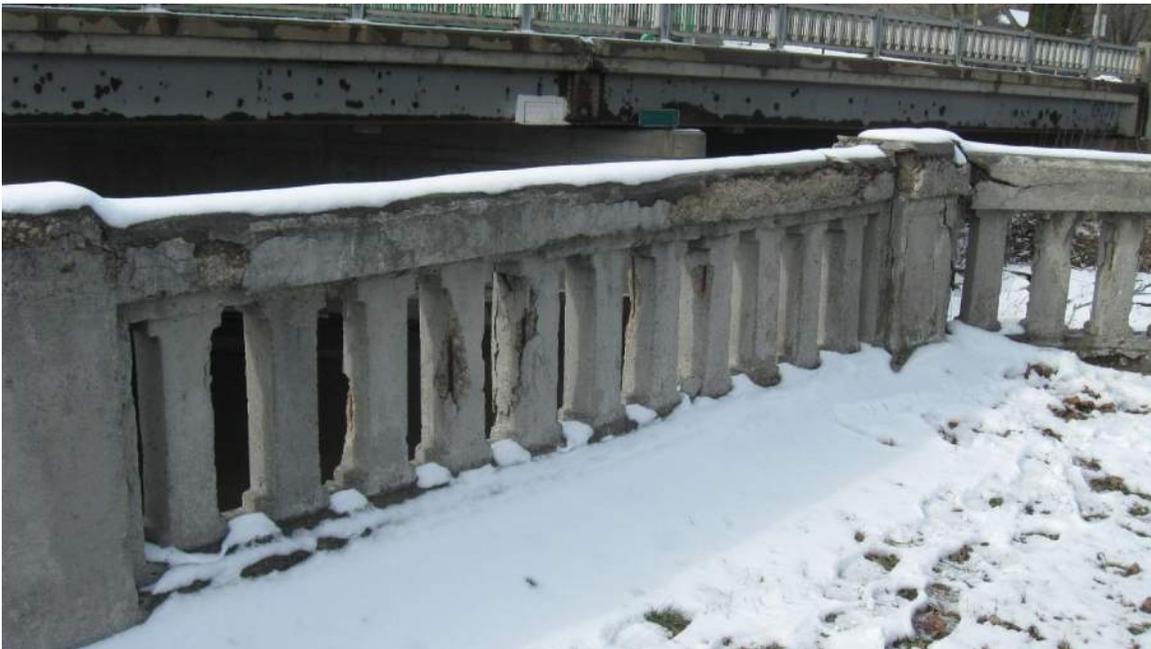
Photograph No. 12

Elevation of Railing in Southwest Quadrant (Interior Face) with Delaminated and Spalled Concrete with Exposed, Corroded Reinforcing Steel

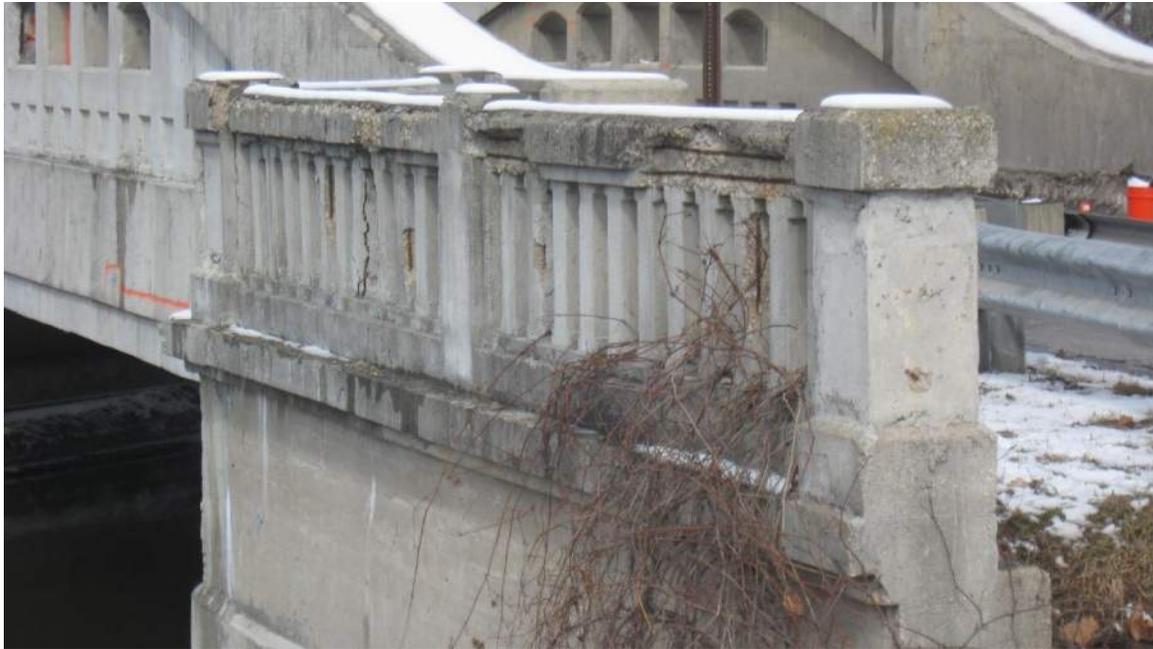
Photograph No. 13

Elevation of Railing in Southwest Quadrant (Exterior Face) with Delaminated and Spalled Concrete with Exposed, Corroded Reinforcing Steel

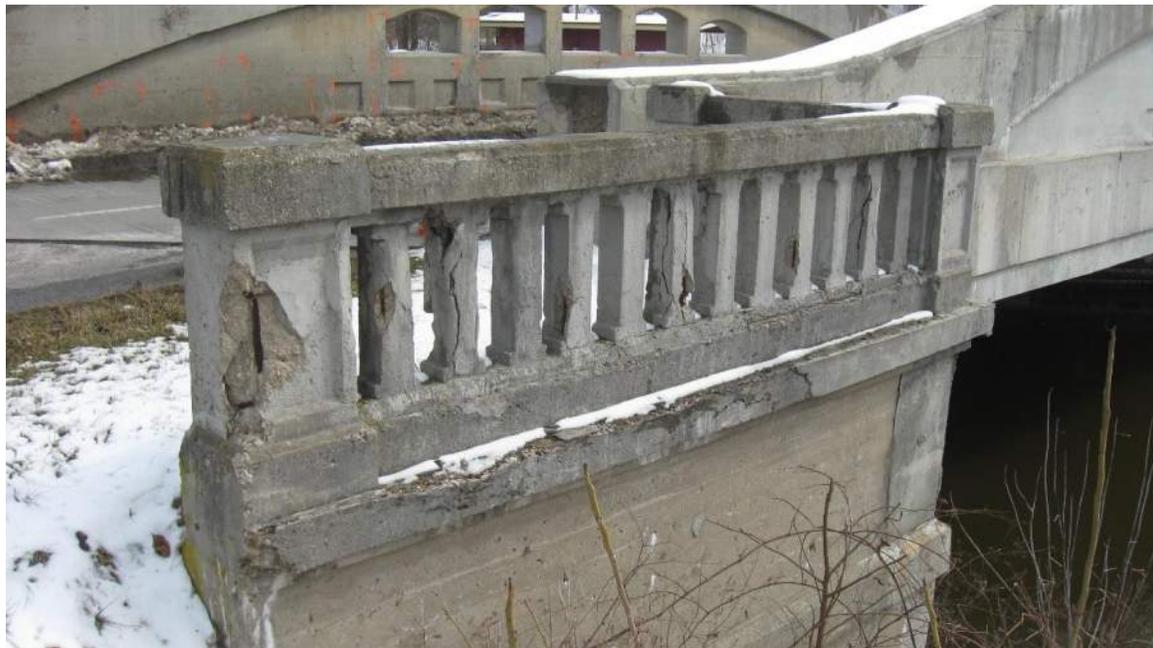
Photograph No. 14

Elevation of Railing in Northwest Quadrant (Exterior Face) with Delaminated and Spalled Concrete with Exposed, Corroded Reinforcing Steel

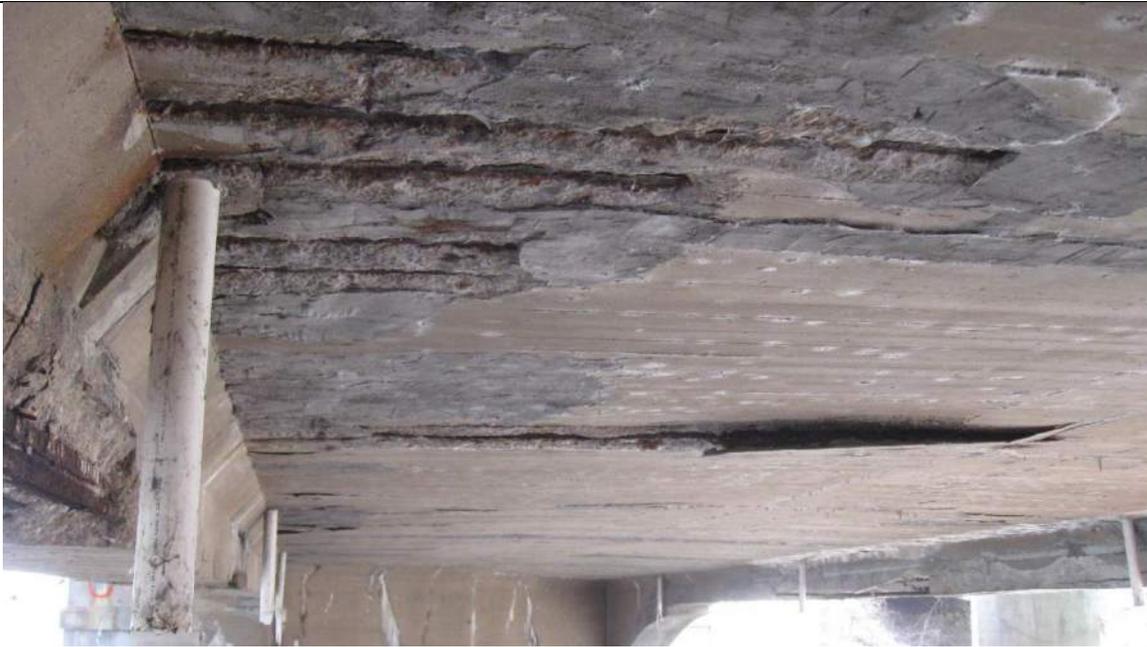
Photograph No. 15

The underside of the deck slab is in poor condition, with numerous failed concrete patches and areas of delaminated, spalled and cracked concrete, with exposed and corroded reinforcing steel (**Photos 15 through 20**).

Large Area of Failed Patch Material with Exposed, Corroded Reinforcing Steel and Large Delaminated Concrete Area on Underside of Deck Slab Along East Arch. Note Spalled Concrete with Exposed, Corroded Reinforcing Steel on Bottom of East Arch at Left.

- Chipping and patching of the top of the deck and sidewalk surfaces, followed by placement of an epoxy overlay
- Chipping and patching of the underside of the deck and sidewalk slabs
- Chipping, patching and concrete crack injection on the abutments and return walls
- Placement of riprap at abutment scour area
- Placement of silane treatment on all exposed concrete surfaces

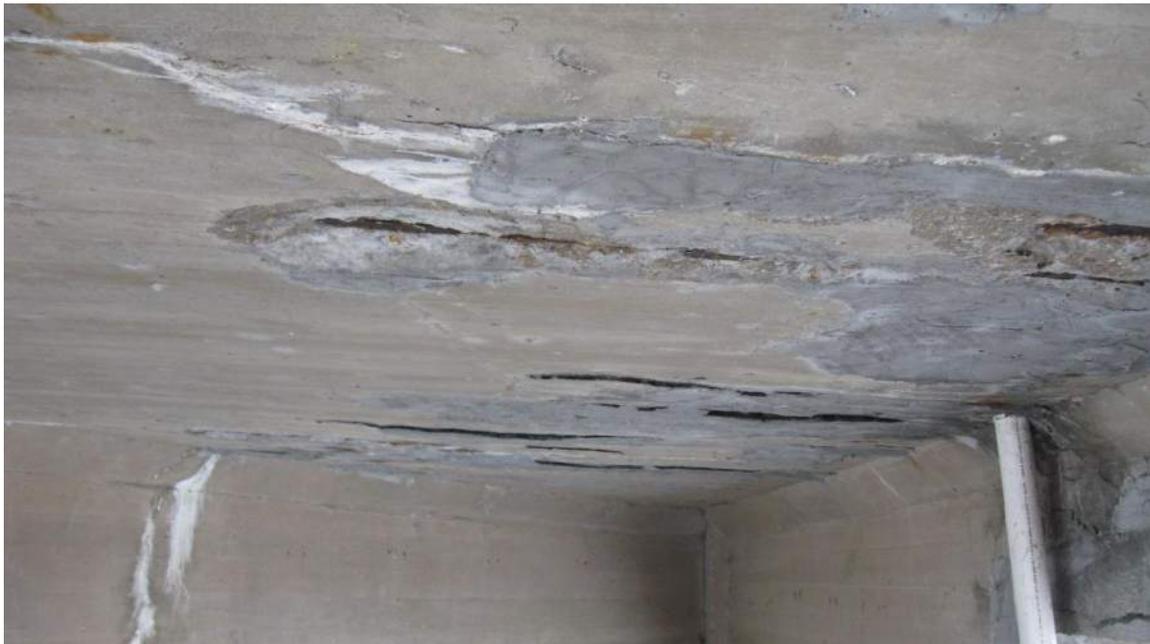
Photograph No. 16

Multiple Failed Patches and Exposed Reinforcing Steel on Underside of Deck Slab, East Side, North End

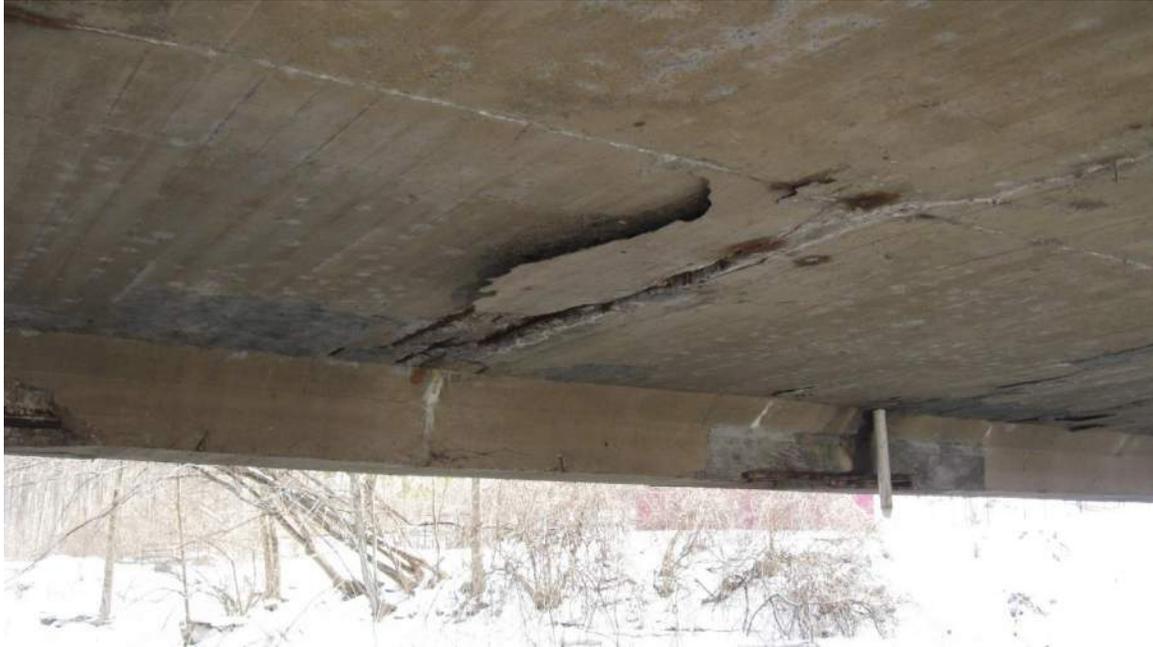
Photograph No. 17

Delaminated and Spalled Concrete, with Exposed and Corroded Reinforcing Steel on Underside of Deck Slab

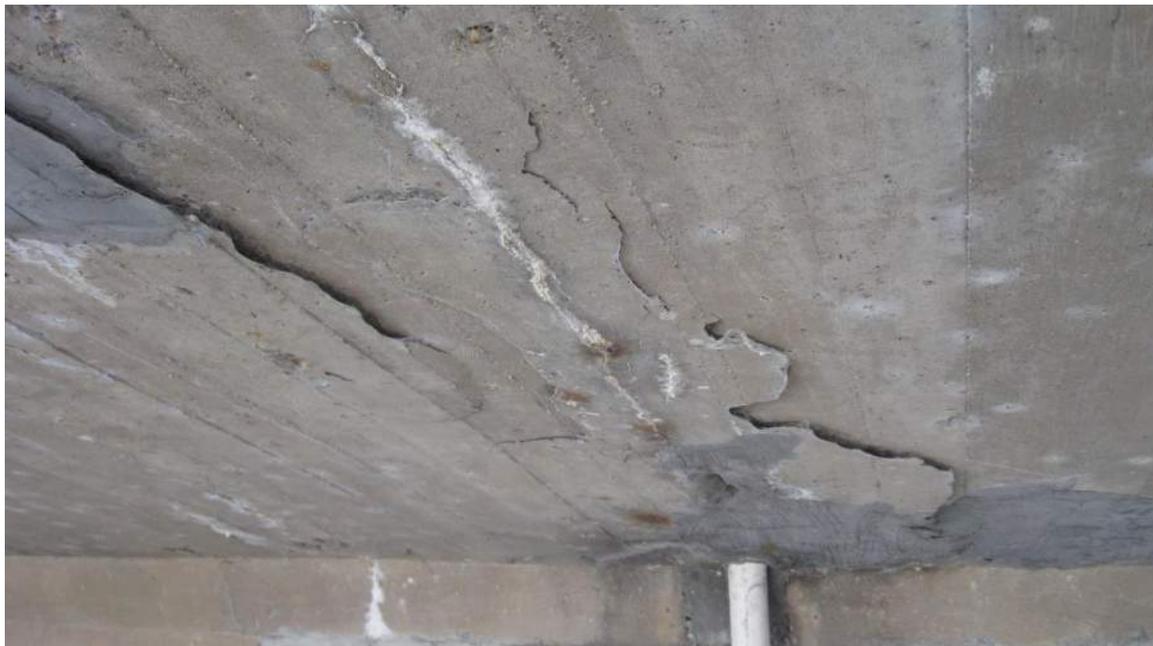
Photograph No. 18

Delaminated Concrete and Delaminated Patches on Underside of Deck Slab

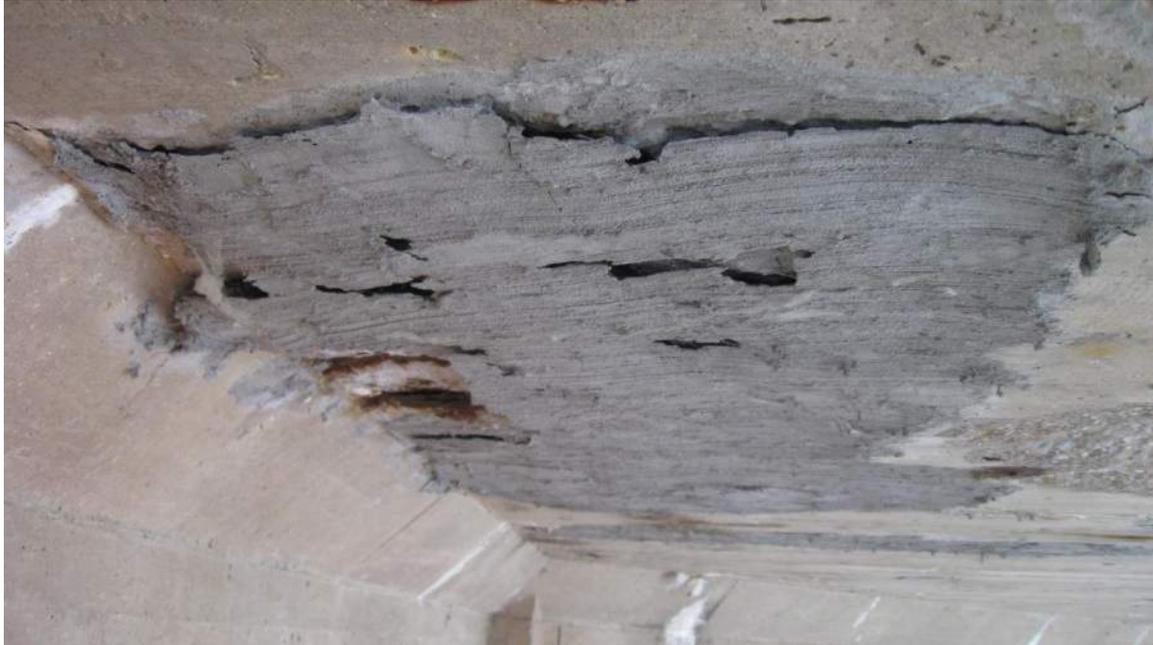
Photograph No. 19

Failed Patch on Underside of Deck Slab, West Side, North End

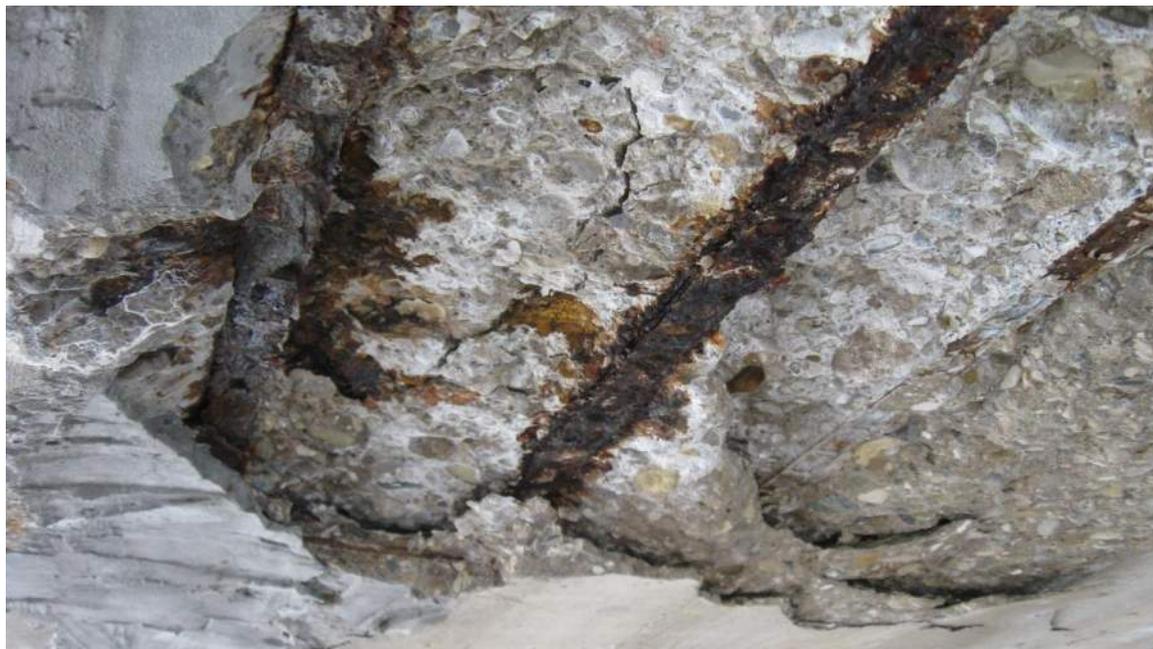
Photograph No. 20

Close-up of Heavily Delaminated and Spalled Concrete Area on Underside of Deck Slab, with Corroded and Exposed Reinforcing Steel, Middle of Deck, North End

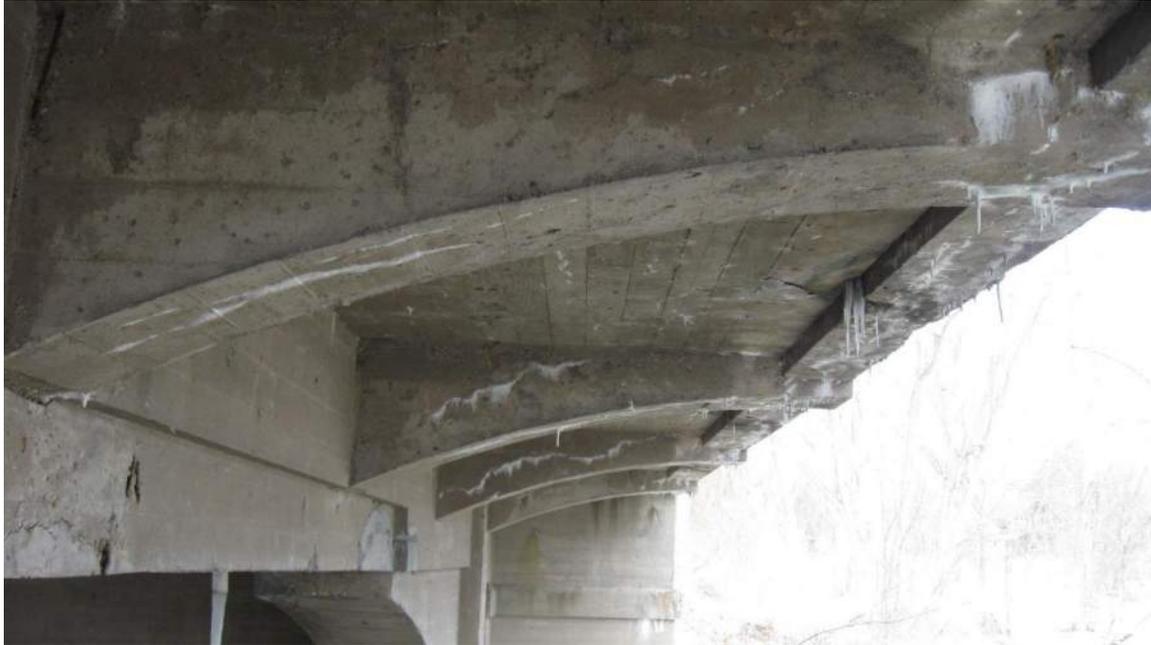
Photograph No. 21

General Condition of Underside of Sidewalk Along East Fascia, with Leaching Cracks

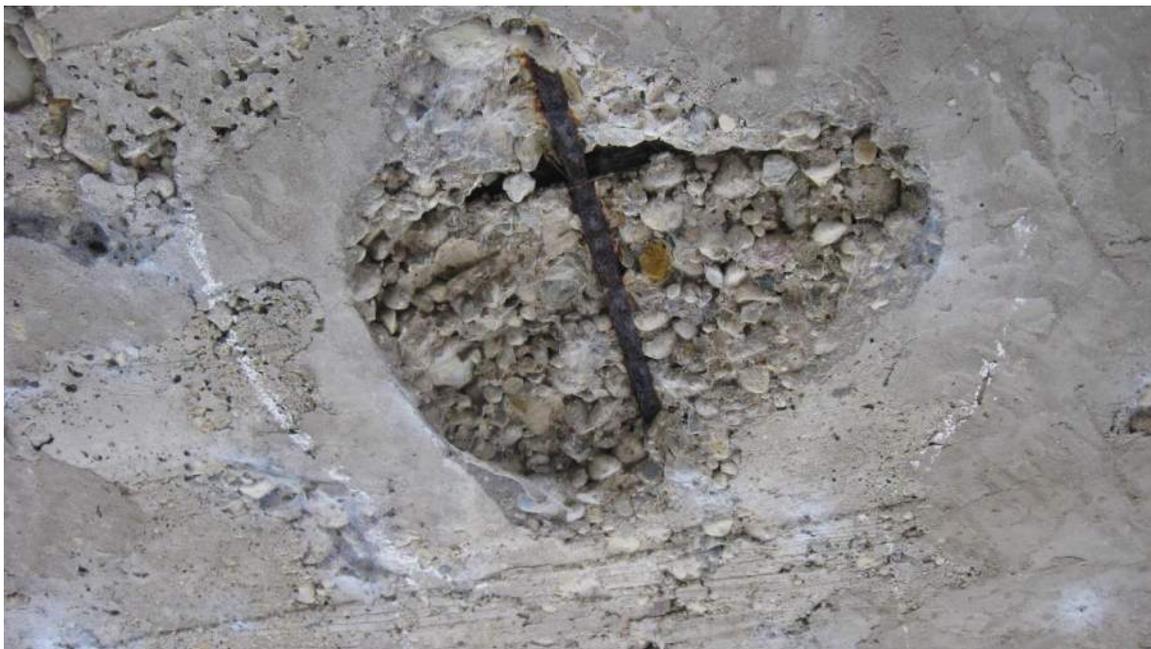
Photograph No. 22

Area of Spalled Concrete with Exposed, Corroded Reinforcing Steel on Underside of Sidewalk

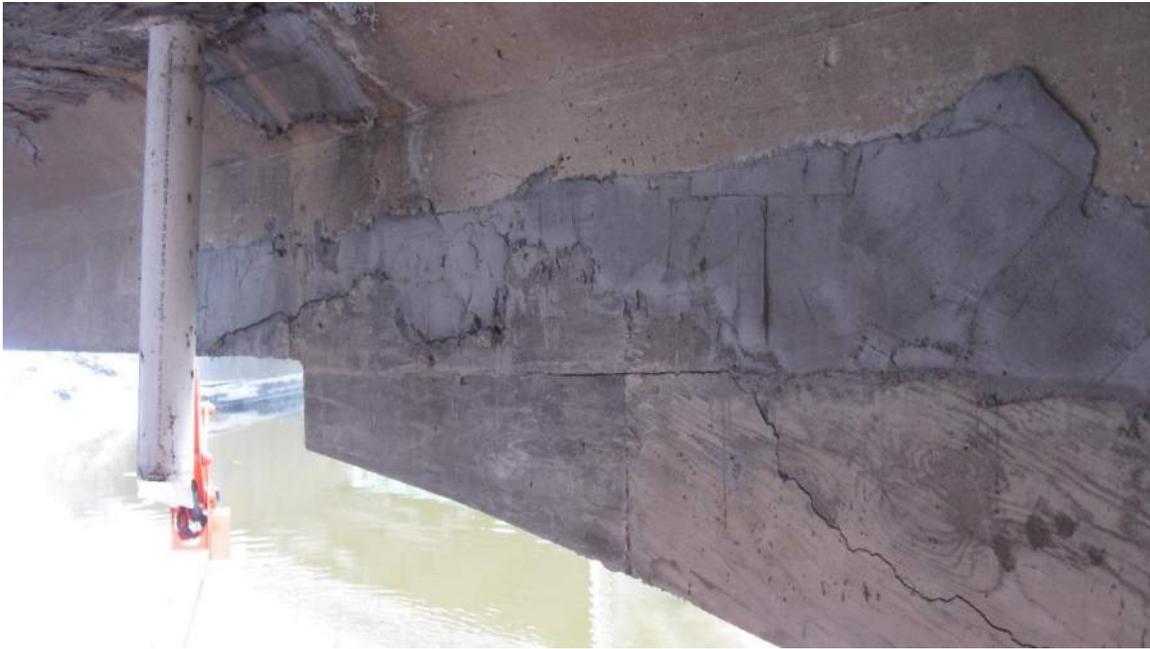
The lower portion of the arches (stringers), below the deck level, have several areas of failed concrete patches, as well as spalled, cracked and delaminated concrete, with exposed and corroded reinforcing steel (**Photos 23 through 30**). The arches/stringers, below the deck level, are in poor condition.

Photograph No. 23
*Delaminated and Cracked Concrete, and Concrete Patch, on East Side of West Arch,
Below Deck Level, Near North End*

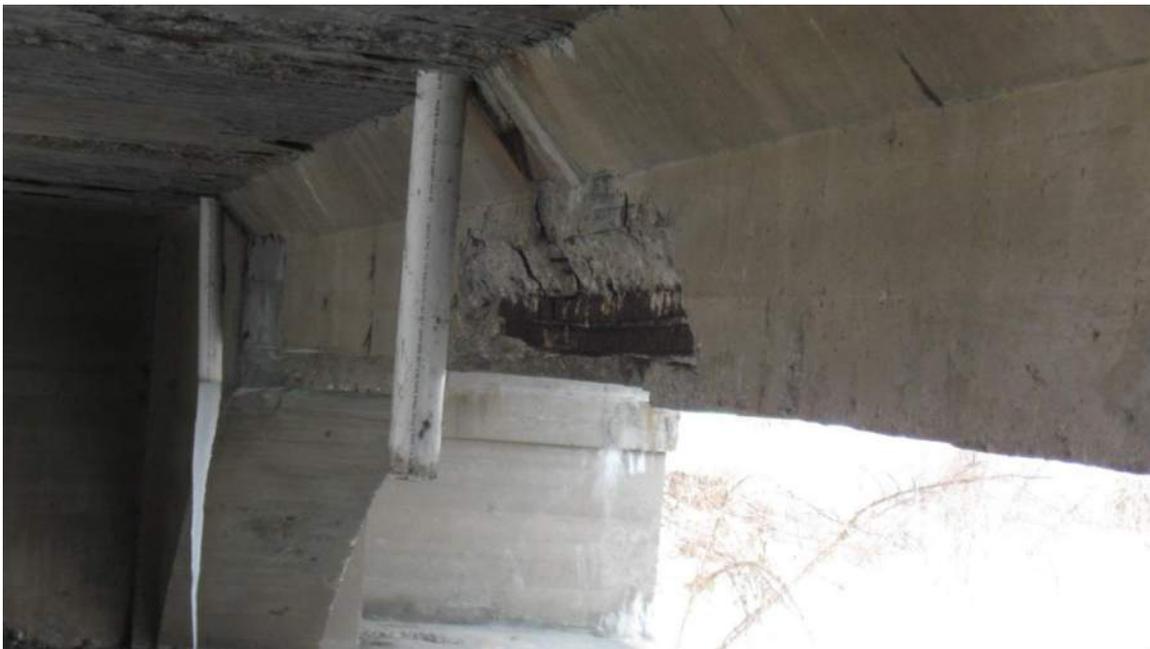
Photograph No. 24
*Delaminated Concrete with Exposed, Corroded Reinforcing Steel on West Side of East Arch,
Below Deck Level, Near North End*

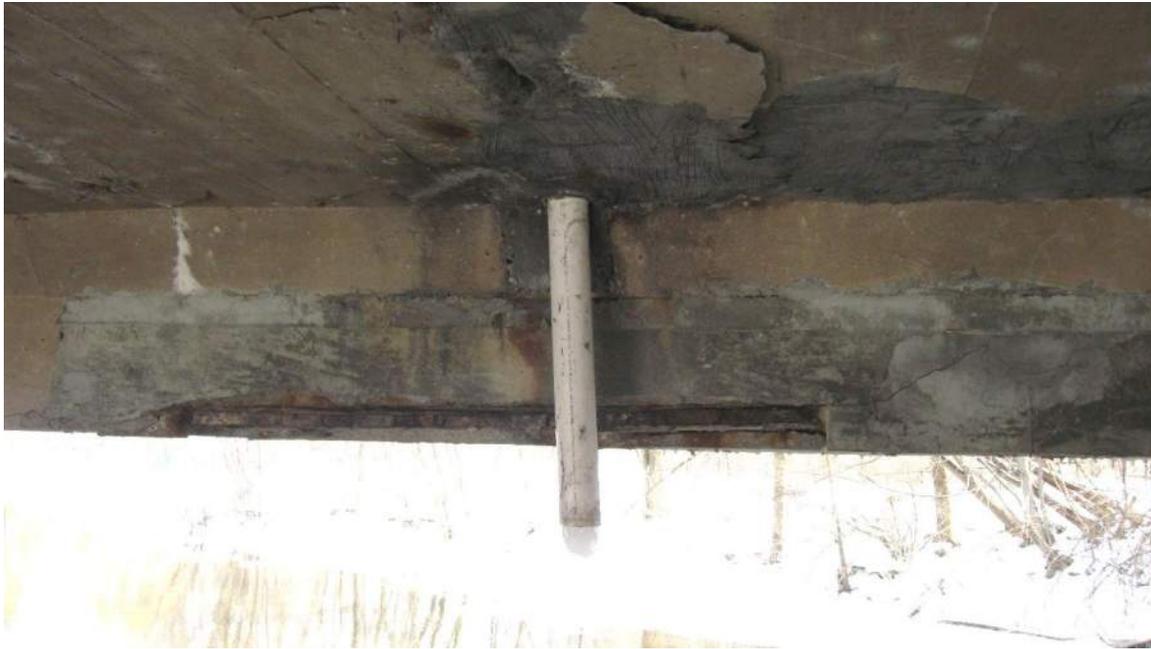
Photograph No. 25
*Delaminated Concrete with Exposed, Corroded Reinforcing Steel on West Side of East Arch
Below Deck Level, Near Mid-Span*

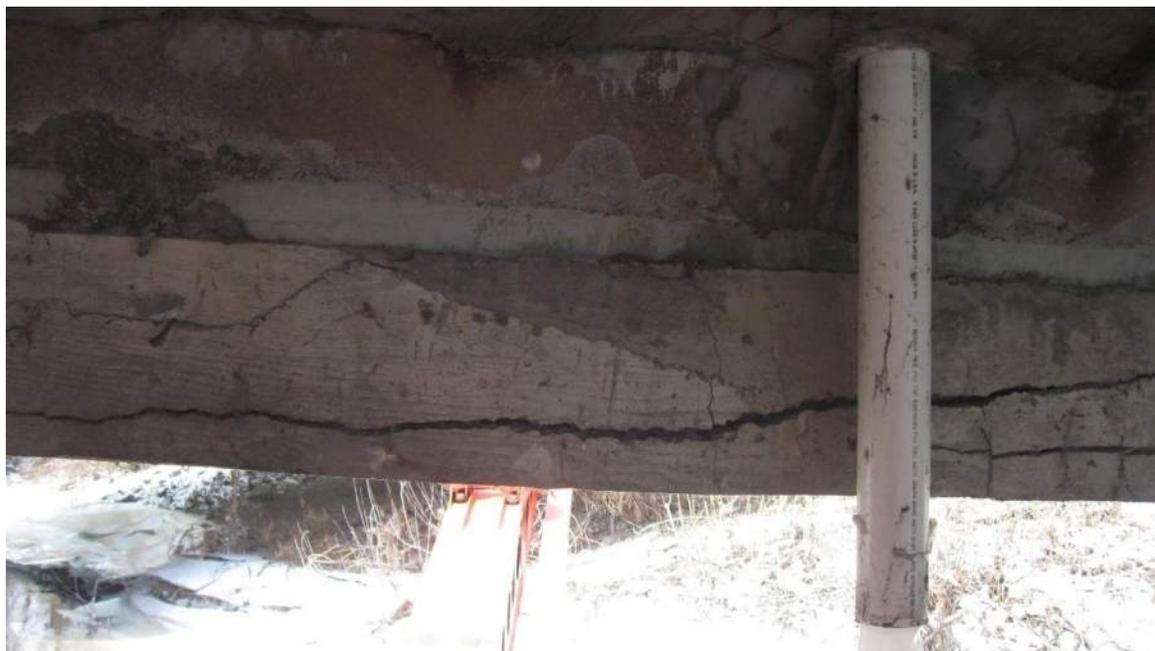
Photograph No. 26
Cracked and Delaminated Concrete on East Side of West Arch, Below Deck Level, North End

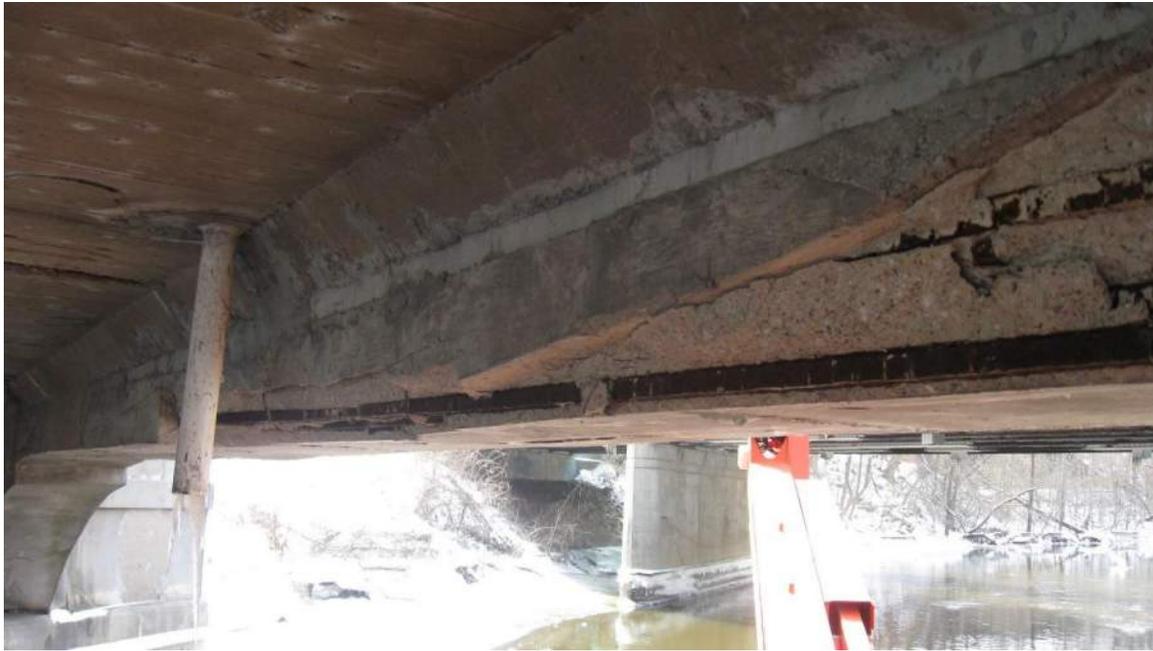
Photograph No. 27

Large Area of Delaminated, Cracked and Spalled Concrete on East Side of West Arch, Below Deck Level, Near South End, with Exposed and Corroded Reinforcing Steel

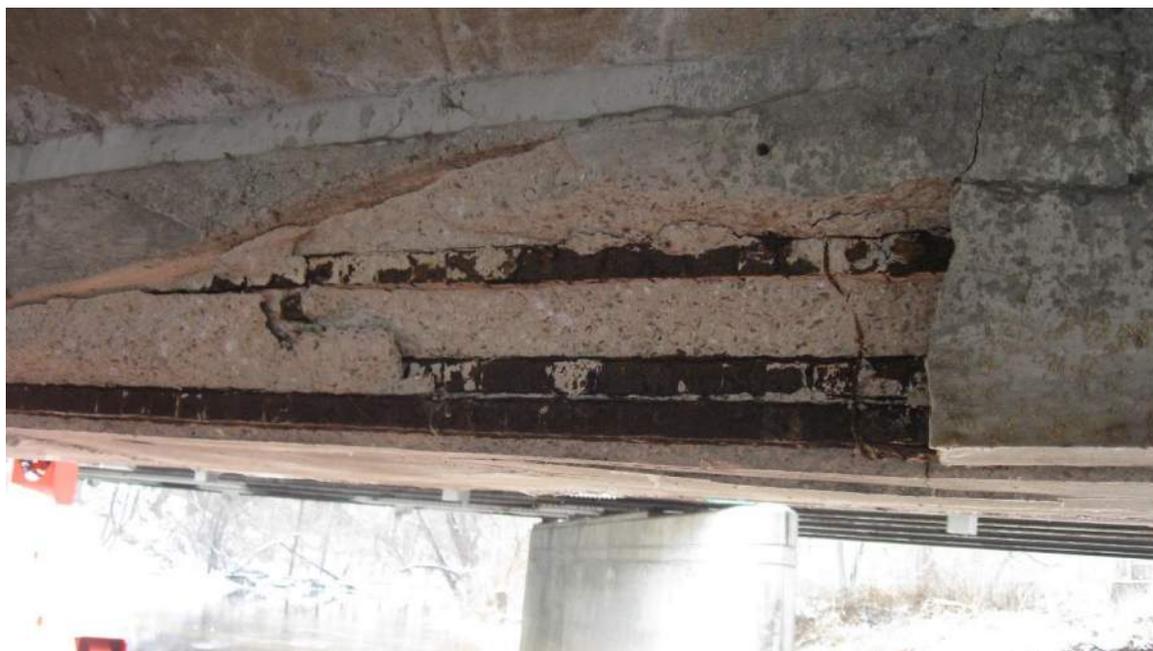
Photograph No. 28

Area of Delaminated, Cracked and Spalled Concrete on East Side of West Arch, Below Deck Level, Near South End, with Exposed and Corroded Reinforcing Steel

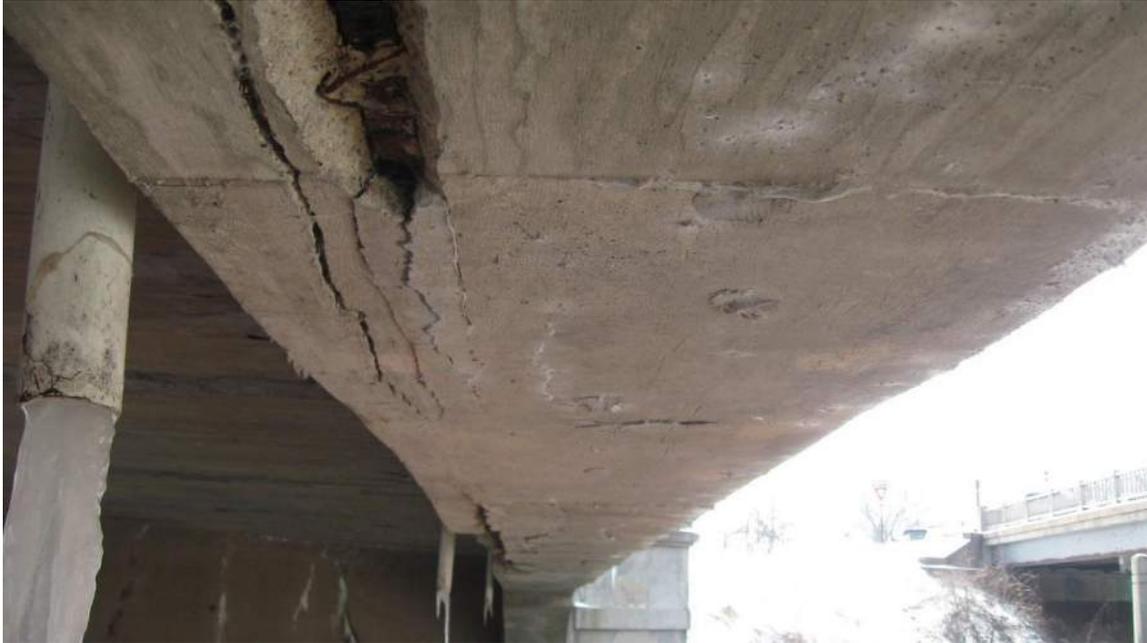
Photograph No. 29

*Looking South at Underside of West Arch, Below Deck Level, Near Mid-Span.
Cracked, Delaminated and Spalled Concrete along East Edge.*

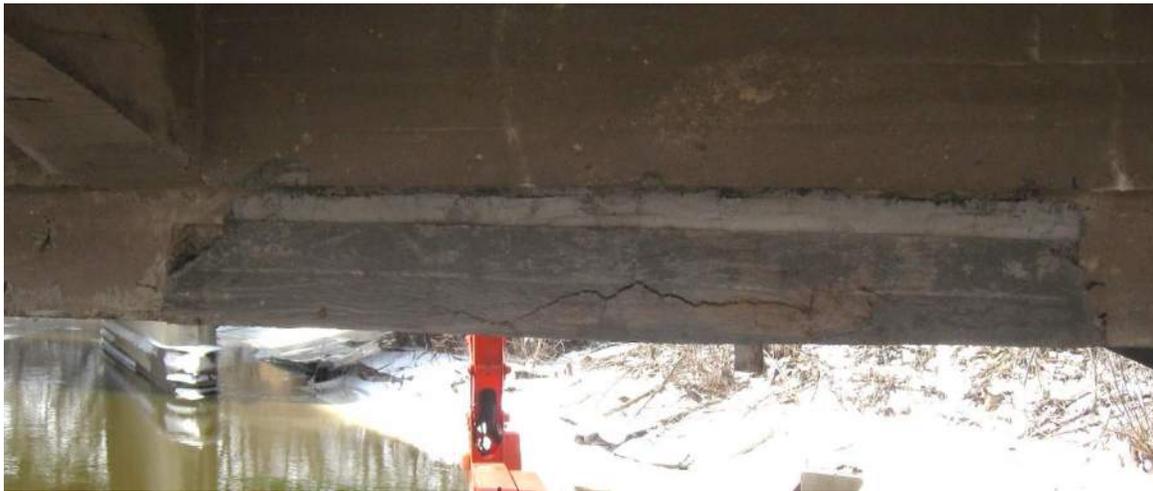
Photograph No. 30

Crack in Patch Material on East Side of East Arch, Below Deck Level, Near North End

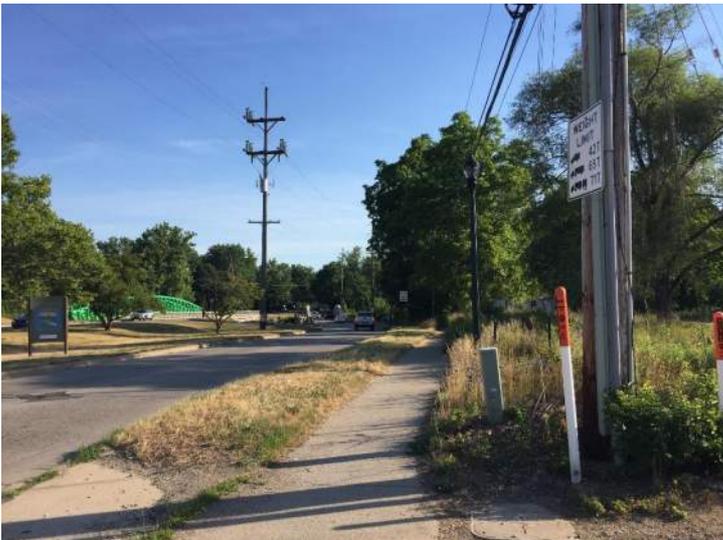
Document Name: 018.JPG
Category: Posting
Span Number:
Comments: Northbound advance posting sign (one way bridge, no sign for SB traffic)
