AGENDA
CHARTER TOWNSHIP OF MERIDIAN
TOWNSHIP BOARD – SPECIAL MEETING
April 16, 2019 6:00 pm

To: Township Board Members
**From: Derek N. Perry, Assistant Township Manager
Director of Public Works & Engineering**
Date: April 16, 2019
Re: Local Street Improvement Program & Funding

To assist with our decision making process, we contracted with DLZ to inspect and prepare a report of their findings on the current condition of the camelback bridge, the cost to make the necessary repairs to serve as a pedestrian bridge and potential future costs to maintain it.

OKEMOS ROAD BRIDGE
IMPROVEMENT PROJECT
ENVIRONMENTAL ASSESSMENT

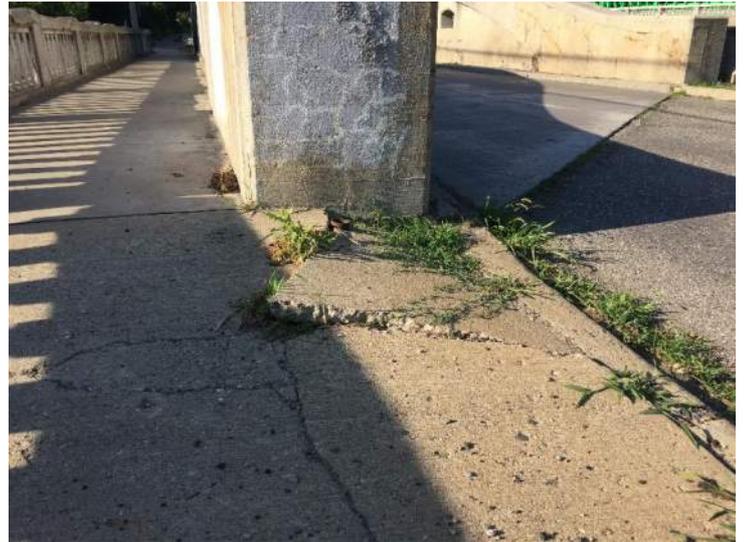
Document Name: 032.JPG
 Category: Approach
 Span Number:
 Comments: Buckled area in northeast approach sidewalk
