LAKE LANSING DAM INSPECTION REPORT

Dam Identification No. 1957
Meridian Township, Ingham County, Michigan

12/29/2025

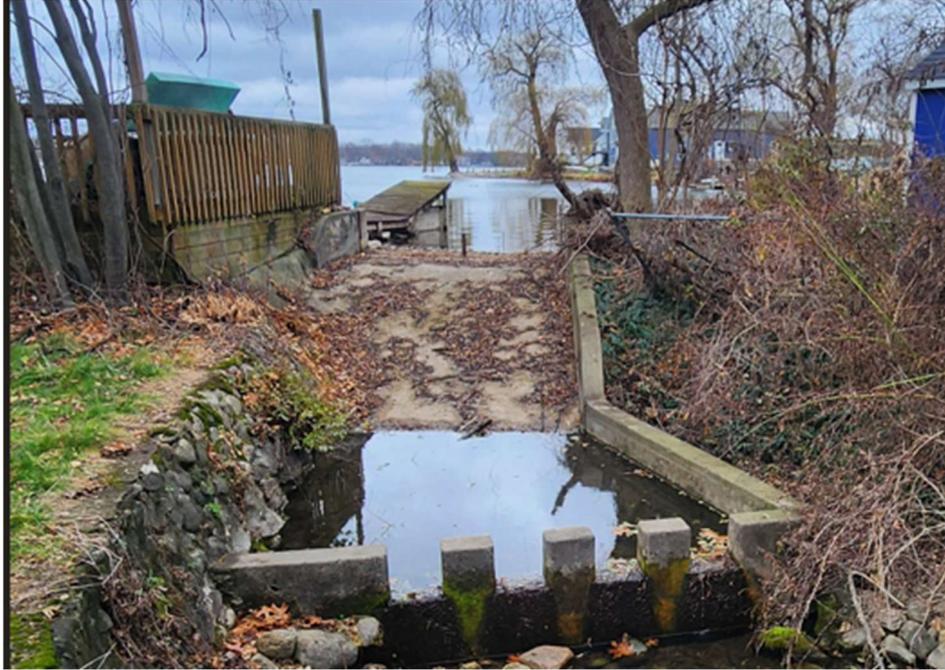
Figure 1 – Still Basin

Figure 1: Shows the concrete stilling basin looking towards the lake.

The still basin at the bottom of the spillway is usually full throughout the year and it is a cause for a foul smell from stagnant water and decomposed fish during the summer months.

6. Evaluate the need to replace the still basin with other means of energy dissipaters.
7. Perform regular clearing and grubbing within the open drain and around culvert.

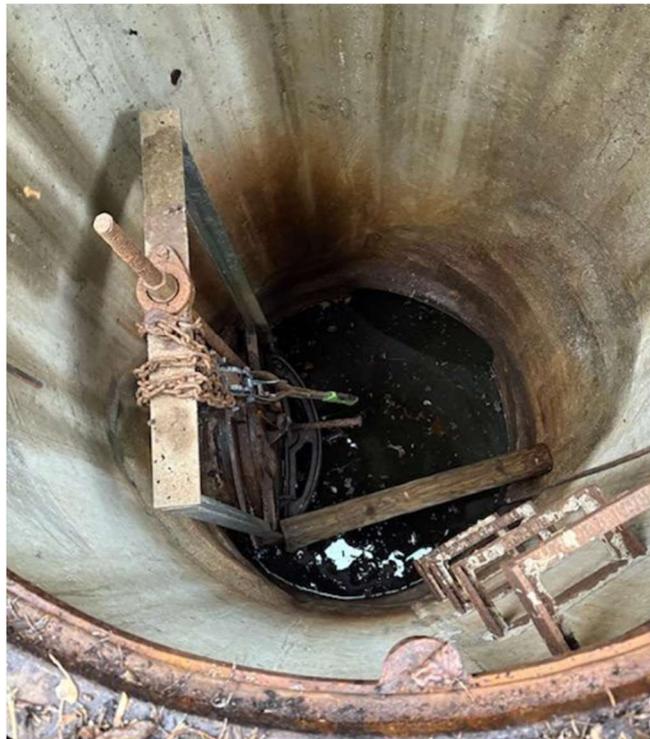
Figure 2 – Slide Gate (Valve)

CMP pipe is in poor condition. Evidence of holes in the pipe. Pipe end seems to be surrounded with sediments which some of it made it downstream, end treatment is recommended. The gate and valve for the outlet pipe are damaged and not operable. Staff has propped the gate closed to prevent water from flowing out. **NEEDS IMMEDIATE ATTENTION.**

Figure 2: Shows the slide gate within the intake structure that controls the level of the lake outside the weirs/spillway control. Some leakage can be seen from the valve.

The slide gate is not operational and is currently propped up by a chain and wedged with a 4x4 to maintain it in a closed position. **It needs to be monitored closely during rain events to make sure it is not going to fail. Otherwise, additional means may be needed to prevent failure since the structure is being reused in the proposed plans.**

2. Replace or perform lining to the existing intake piping while replacing the valve control structure for lowering the lake level; Establish new uplift control for new/rehabilitated pipe with appropriate screening to prevent fish and other debris from washing downstream when the valve is open.

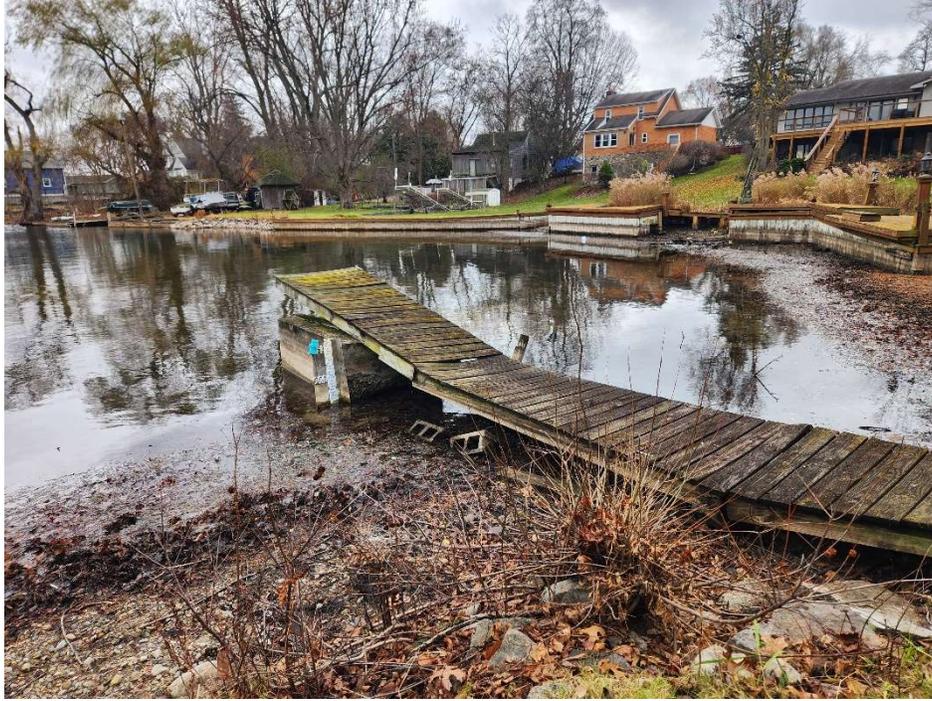
Figure 3 – Wooden Dock

Figure 3: Show the condition of the wooden dock.

The wooden dock is in very poor condition. The dock is unstable and unsafe to walk on. It needs to be repaired or replaced.

3. Repair damaged concrete structures.
4. Relevel water level measuring device on the concrete structure for a more accurate lake level reading.
5. Replace the wooden dock and maybe eliminate the deck over the valve control structure when performing the upgrade.

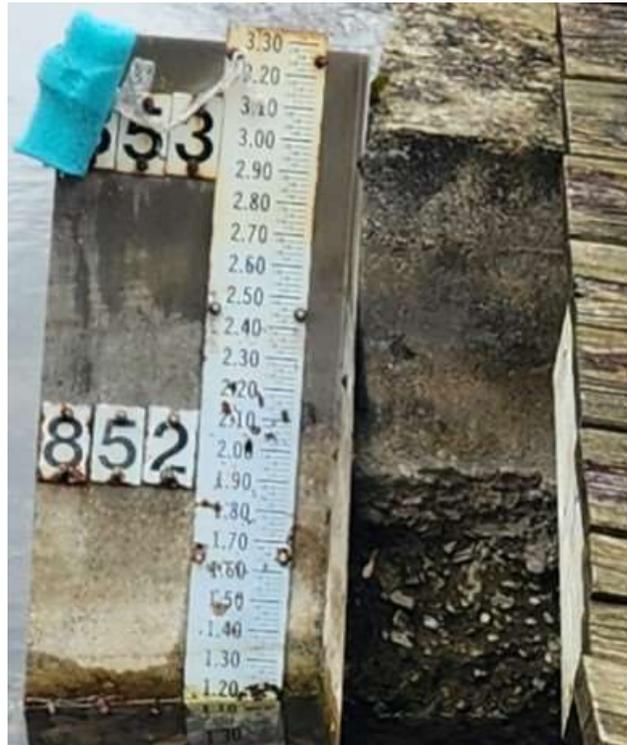
Figure 4 – Water Level

Figure 4: Indicates the water level of the lake at the time of inspection.

The water level measuring device located along the concrete slab at the end of the dock has shifted and needs to be relevelled to its original location. This will allow for a more accurate reading of the lake level as the water level is currently monitored on a monthly basis by maintenance staff. The installation of a remote sensor that reports water level information accessible via internet could also be installed to reduce the number of visits needed for water level monitoring.

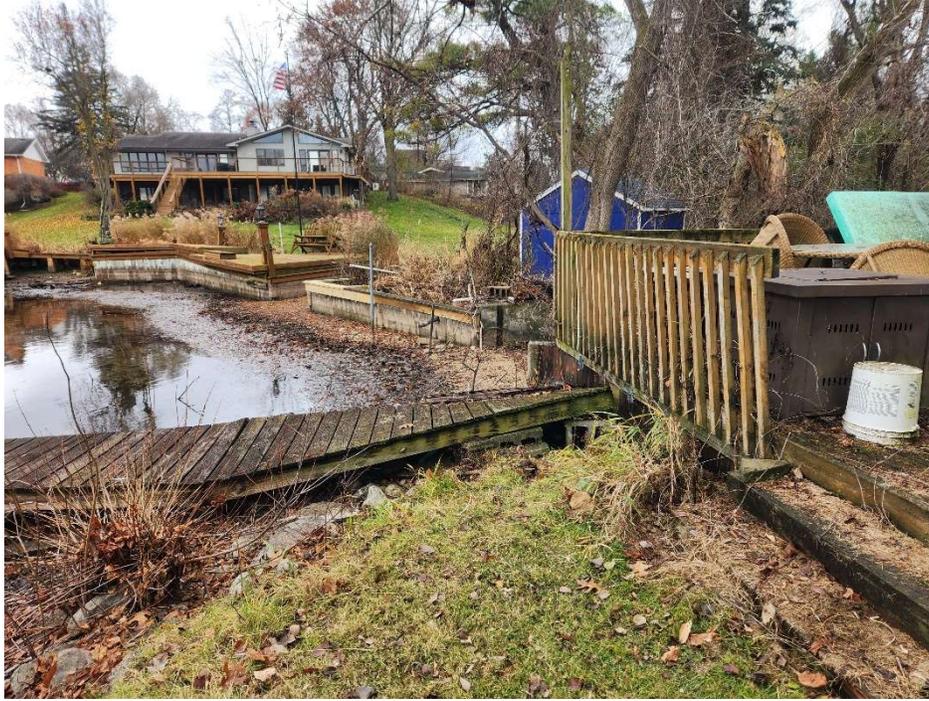
Figure 5 – Sea Wall and Approach to Spillway from the Dock location

Figure 5: Shows the Sea Wall and Approach to Spillway from the Dock location.

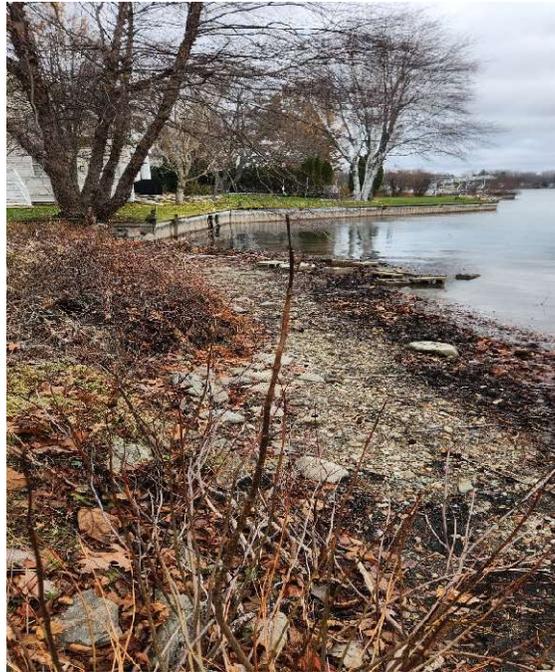
Figure 6 – Riprap Shoreline Right of Spillway from the Dock location

Figure 6: Shows the riprap shoreline right of the spillway.

No significant erosion was observed at the time of inspection. It is recommended regular upkeep be done to prevent possible erosion.

8. Perform regular upkeep on areas that experience erosion.

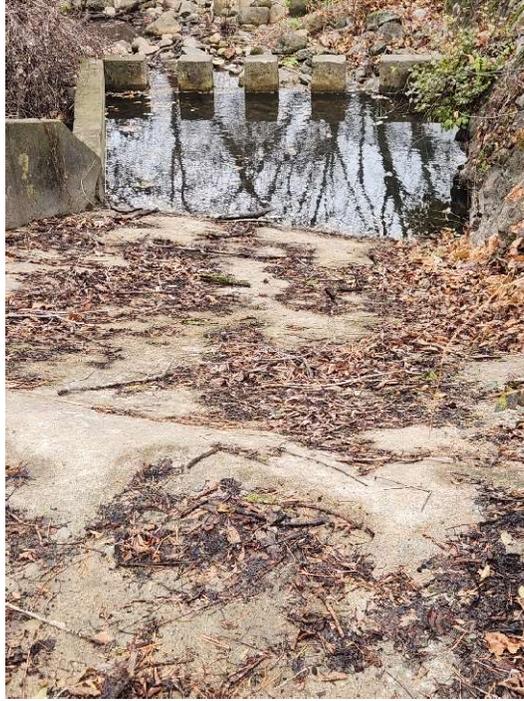
Figure 7 – Spillway

Figure 7: Shows the spillway.

The spillway and water level control structure are in satisfactory condition with some minor cracks and spalling. Vines seem to be growing through some of the cracks along the spillway edge. The spillway, however, does not allow for fish to pass from Lake Lansing into the Pine Lake Outlet Drain. Modifications could be made to the spillway to allow for fish passage and to repair the cracked concrete around the pipe.

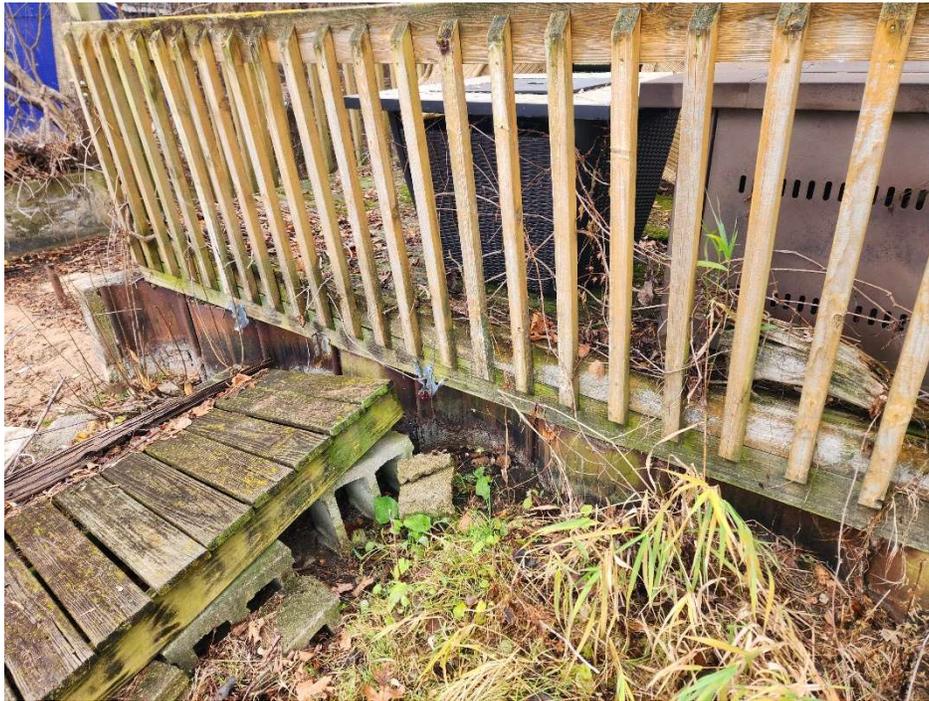
Figure 8 – Sheet Piling Right of Spillway

Figure 8: Shows the sheet piling under the wooden deck.

The sheet piling has shown some signs of corrosion and needs to be mitigated. Replacement may be an option, but other means could be considered such as restoration and painting of the steel while installing an outside concrete barrier for further protection.

1. Perform rehabilitation of the corroded upper portion of the sheet piling along the span of the dam. (sandblasting, painting and encasement with concrete)

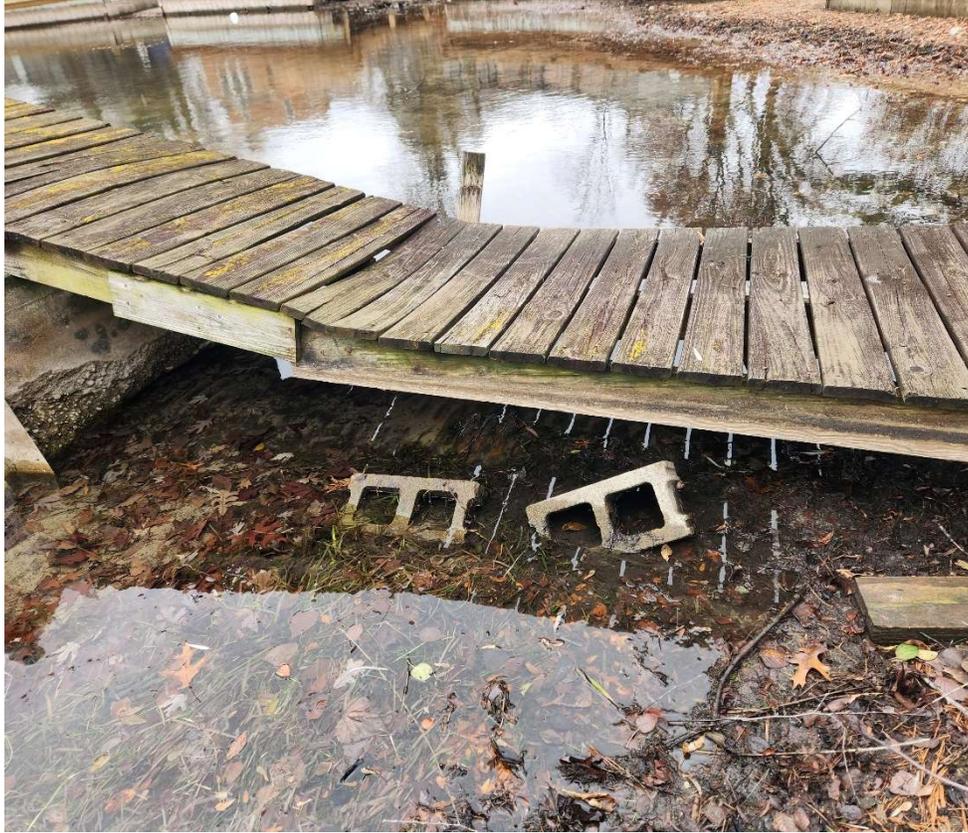
Figure 9 – Intake Pipe under the Dock

Figure 9: Shows the intake pipe underneath the dock.

The intake pipe which is located immediately underneath the wooden dock has rusted out and is pitted in many locations along its length. The condition could be observed, during previous inspections, when the valve is operational as bubbles are seen where holes are present. Furthermore, the intake pipe lacks any screens as to prevent fish or debris from washing into the drain.

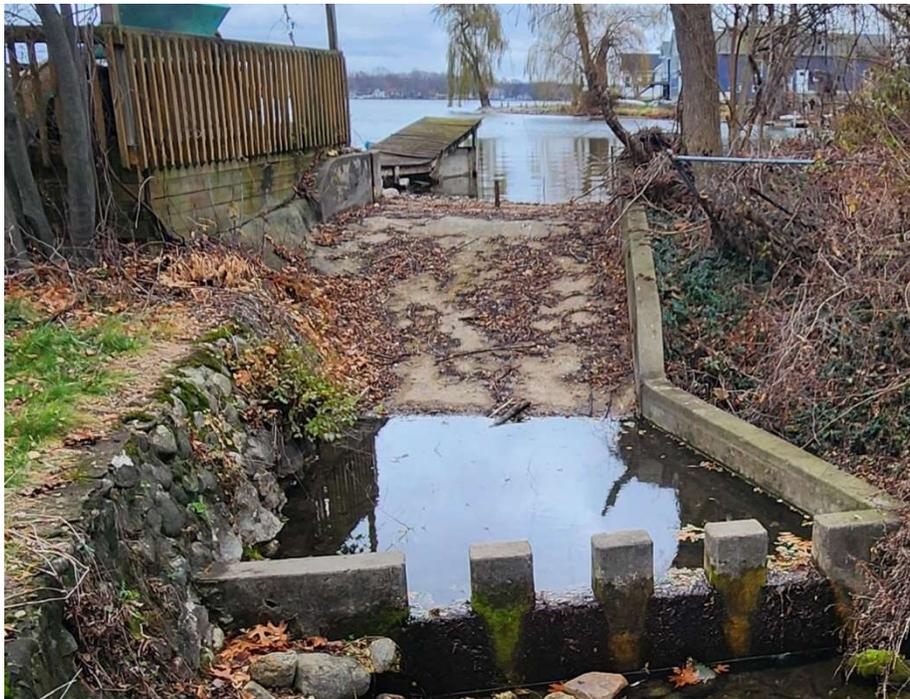
Figure 10 – Spillway looking towards the Lake

Figure 10: Shows the Spillway looking towards the Lake.

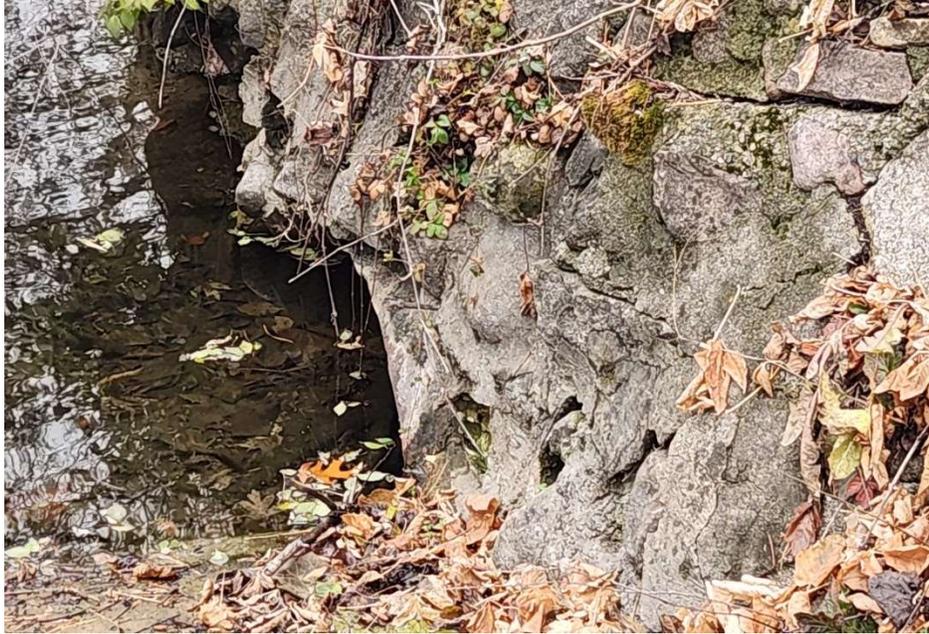
Figure 11 – Bypass Pipe into Still Basin

Figure 11: Shows the Bypass Pipe into Still Basin.

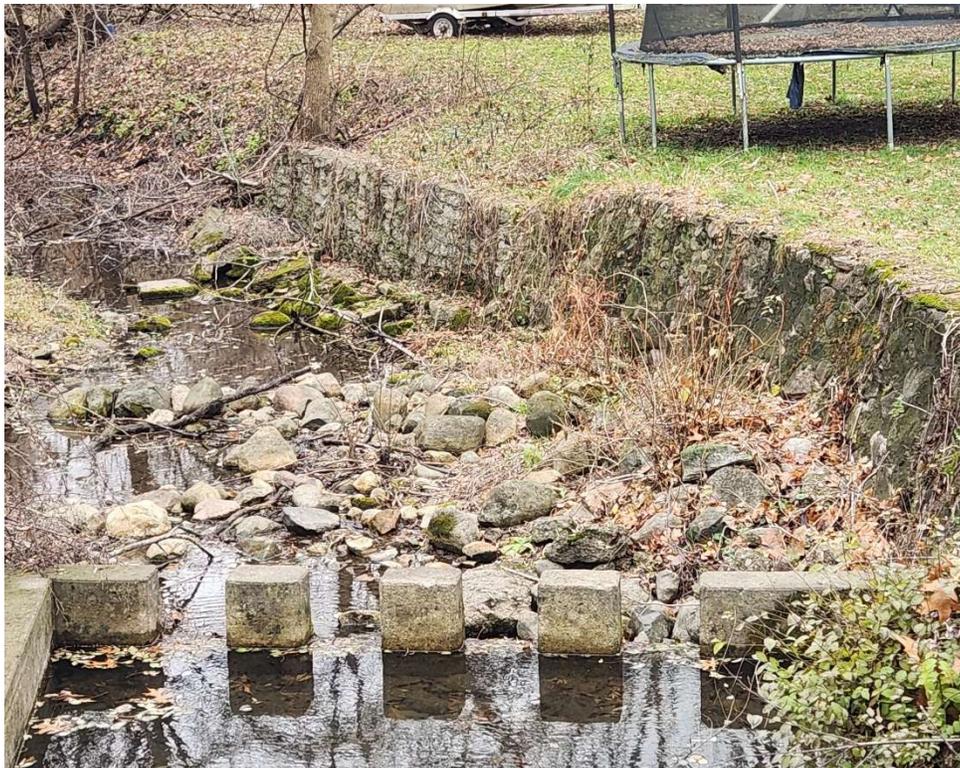
Figure 12 – Open Channel Looking downstream

Figure 12: Shows the open channel looking downstream toward the Marsh Rd. outlet structure.

The outlet drain is in good condition. Regular clearing and grubbing of vegetation are recommended within the open channel to remove obstructions. **The tree along one side of the spillway is being undermined and will need to be removed and area repaired.**

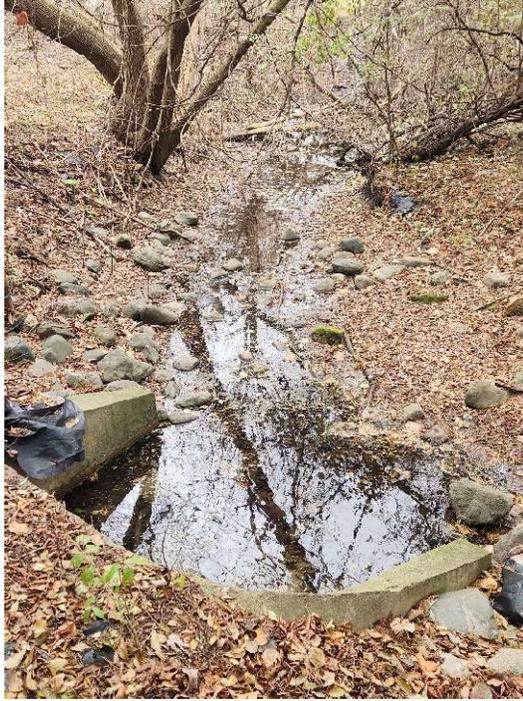
Figure 13 - Marsh Rd. Outlet Structure: East End

Figure 13: Shows the Marsh Rd. outlet structure on the east side of Marsh Rd.

The outlet culvert is in good condition. Regular clearing and grubbing of vegetation around the outlet culvert are recommended especially along the downstream end of the culvert west of Marsh Road.

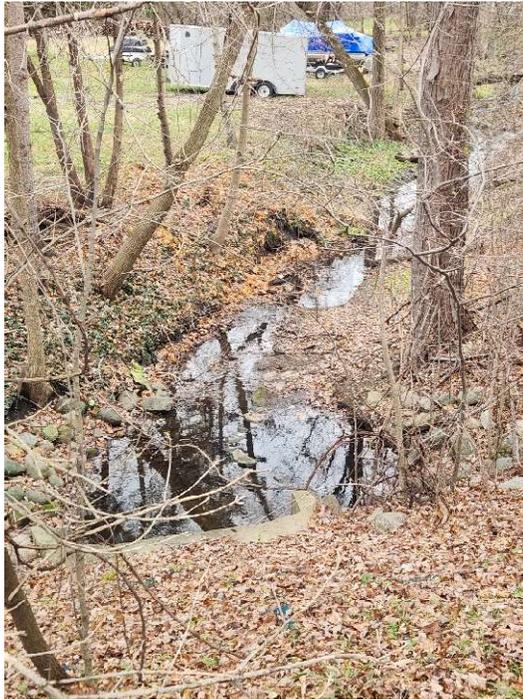
Figure 14 – Marsh Rd. Outlet Structure: West End

Figure 14: Shows the Marsh Rd. outlet structure on the west side of Marsh Rd.

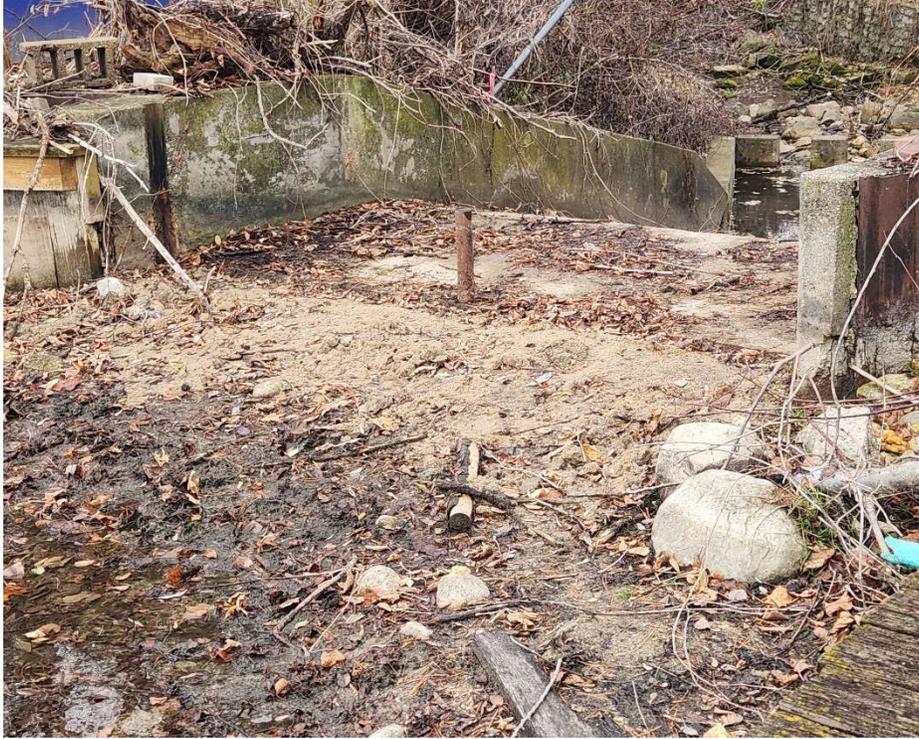
Figure 15 – Stop Log Channel

No stop logs were in place at the time of inspection. Water was low with no flowing water over the weir at the time of inspection. Stop log channel could use some upgrades but Maintenance personal report that the logs maintain the summer lake level satisfactorily.

Figure 15: Shows the Stop Log Channel.

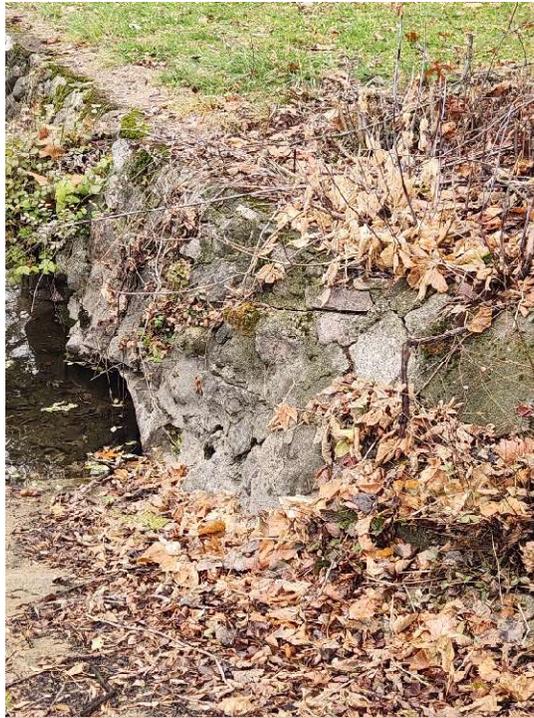
Figure 16 – Spillway edge where vines are growing through cracks

Figure 16: Shows the Spillway edge where vines are growing through cracks.

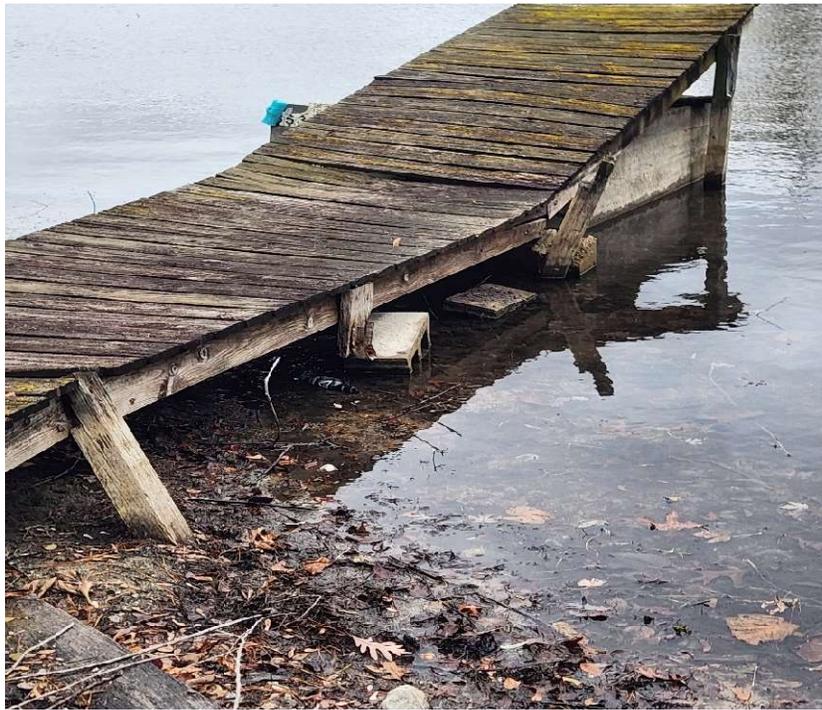
Figure 17 – Dock Condition over the inlet structure

There are no walkways or railings. Deck and dock over drawdown pipe and valve are in very poor condition. The dock has fallen apart and unsafe to walk on. The valve is inoperable, and the deck need some attention before the next inspection. **Recommend replacement of control structure, pipe, valve and related support structures ASAP.**

Figure 17: Indicates the Dock Condition over the inlet structure.

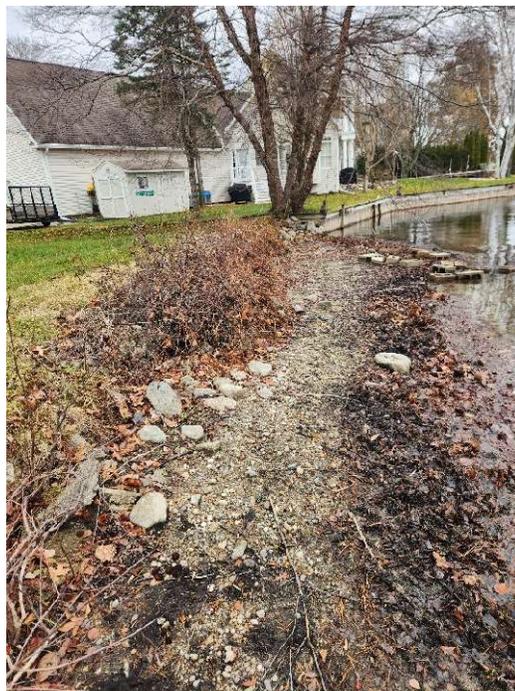
Figure 18 – Seawall right of Spillway

Figure 18: Shows the Seawall right of Spillway.
