LAKE LANSING DAM INSPECTION REPORT

Dam Identification No. 1957
Meridian Township, Ingham County, Michigan

1/7/2020

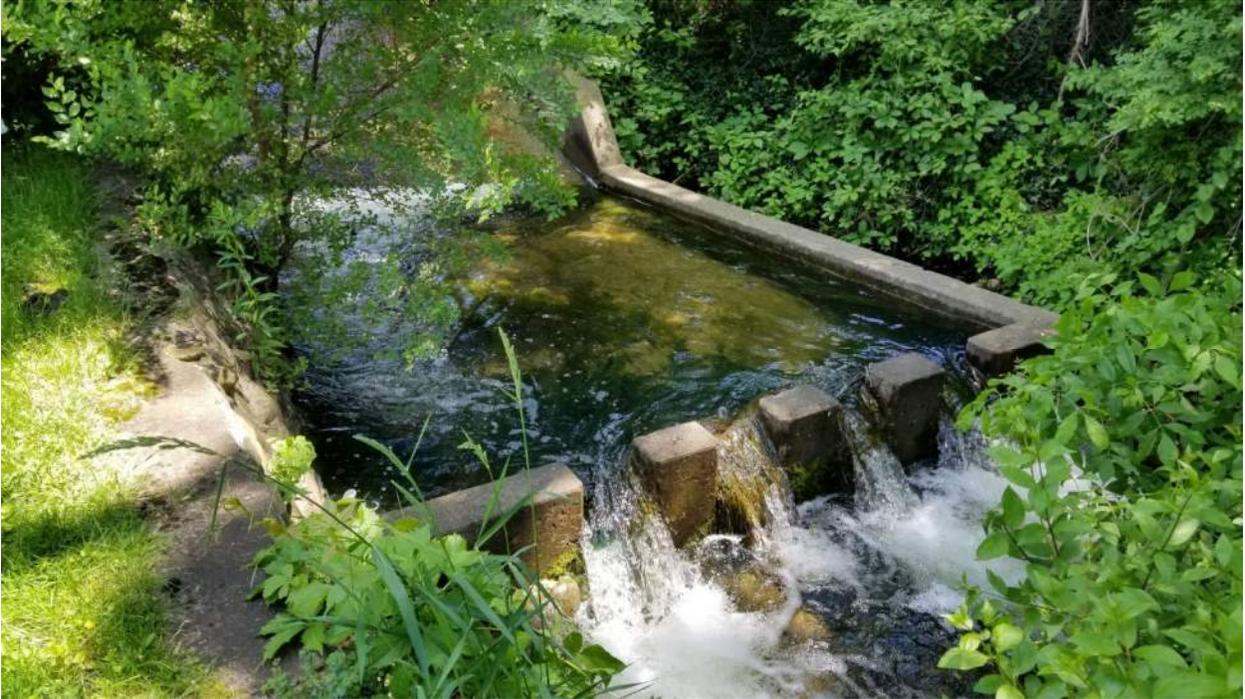
Figure 1 – Still Basin

Figure 1: Shows the concrete stilling basin looking towards the lake. (June 7th, 2019)

The still basin at the bottom of the spillway is usually full throughout the year and it is a cause for a foul smell from stagnant water and decomposed fish during the summer months.

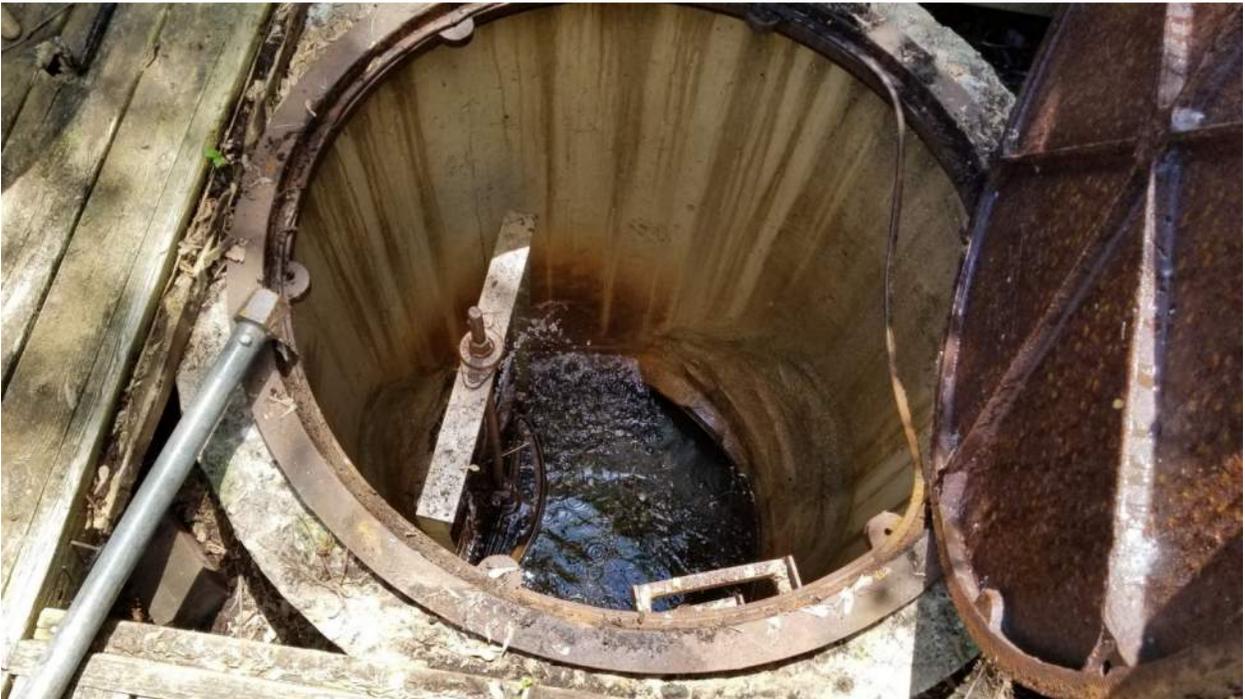
Figure 2 – Slide Gate (Valve)

Figure 2: Shows the slide gate within the intake structure that controls the level of the lake outside the weirs/spillway control. Some leakage can be seen from the valve. (June 7th, 2019)

The slide gate is still operational but does allow for some limited water seepage.

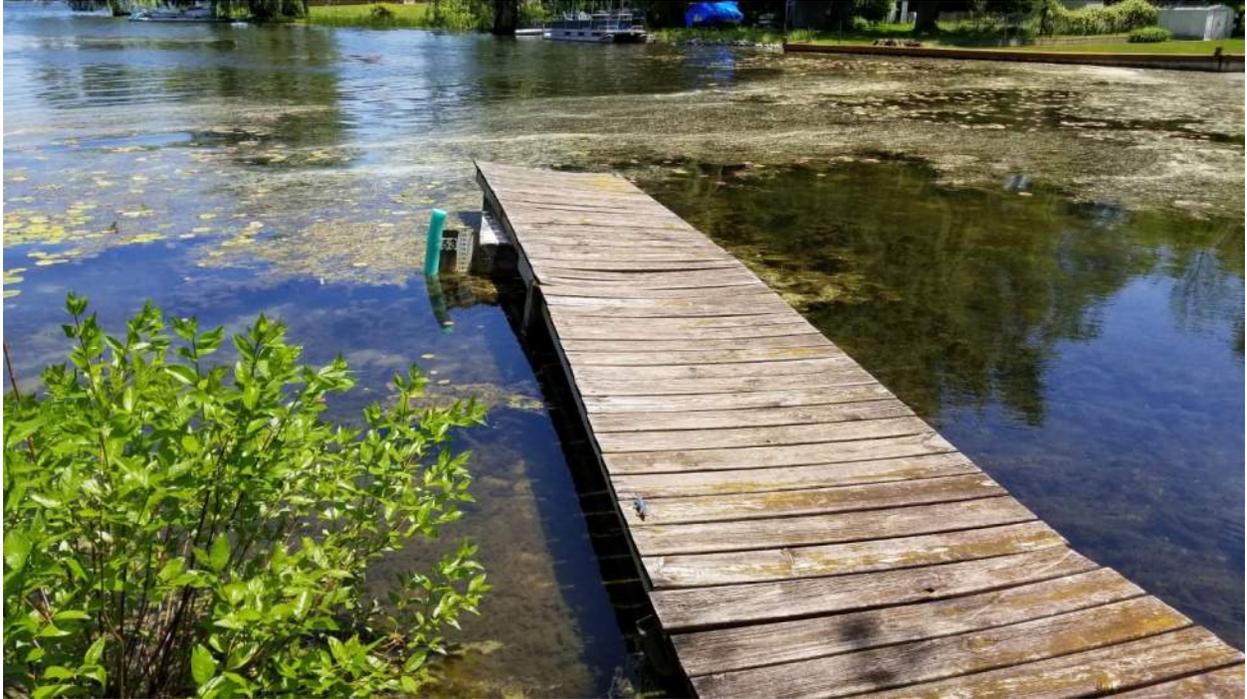
Figure 3 – Wooden Dock

Figure 3: Show the condition of the wooden dock. (June 7th, 2019)

The wooden dock is in very poor condition. The dock is unstable and unsafe to walk on. It needs to be repaired or replaced.

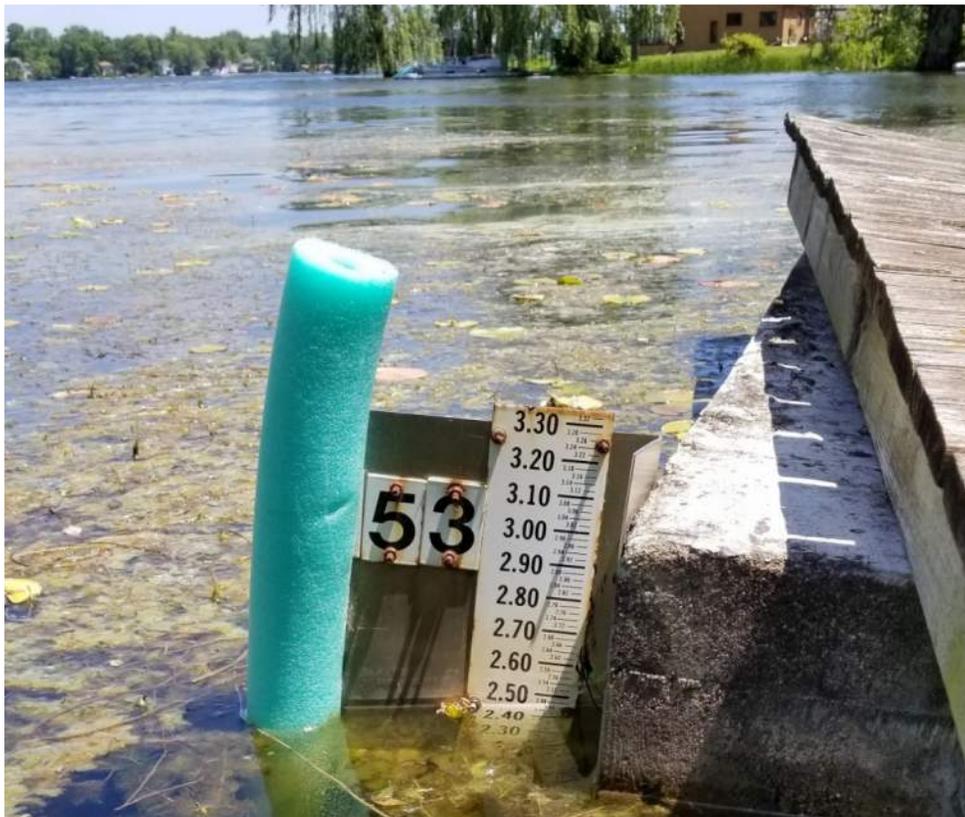
Figure 4 – Water Level

Figure 4: Indicates the water level of the lake at the time of inspection and shows that the measuring device has shifted over time. (June 7th, 2019)

The water level measuring device located along the concrete slab at the end of the dock has shifted and needs to be releveled to its original location. This will allow for a more accurate reading of the lake level as the water level is currently monitored on a monthly basis by maintenance staff. The installation of a remote sensor that reports water level information accessible via internet could also be installed to reduce the number of visits needed for water level monitoring.

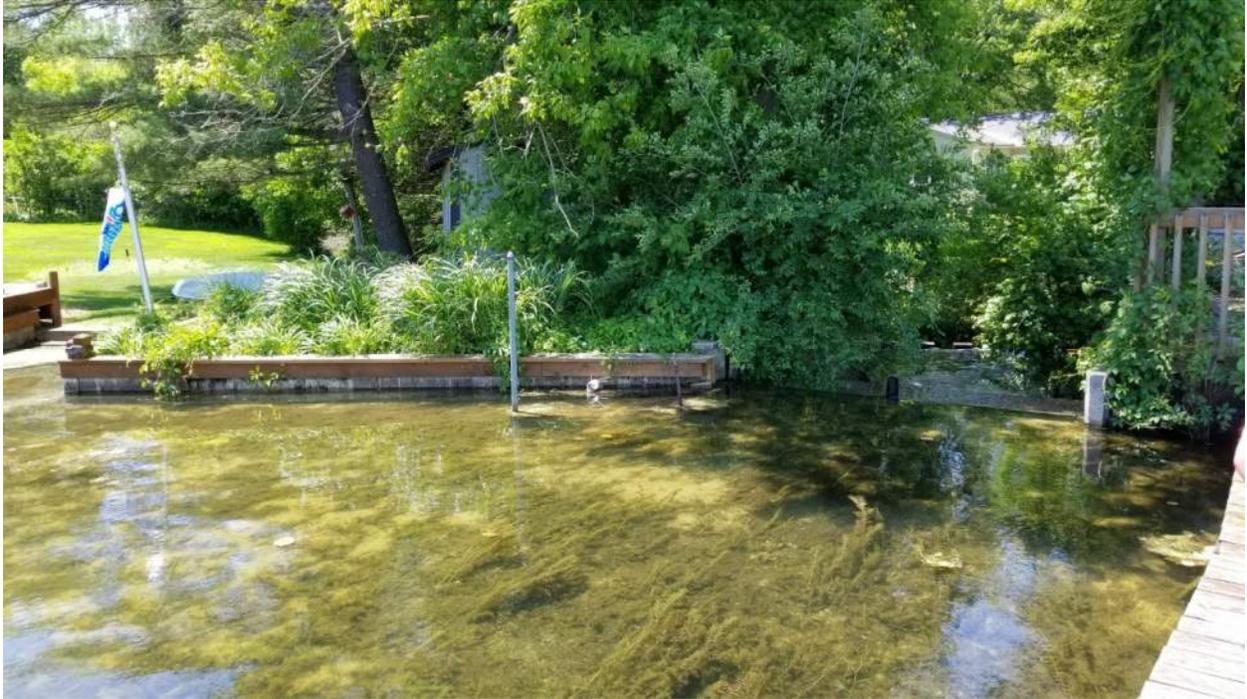
Figure 5 – Sea Wall and Approach to Spillway from Dock

Figure 5: Shows the approach of the spillway from the landowners' dock. (June 7th, 2019)

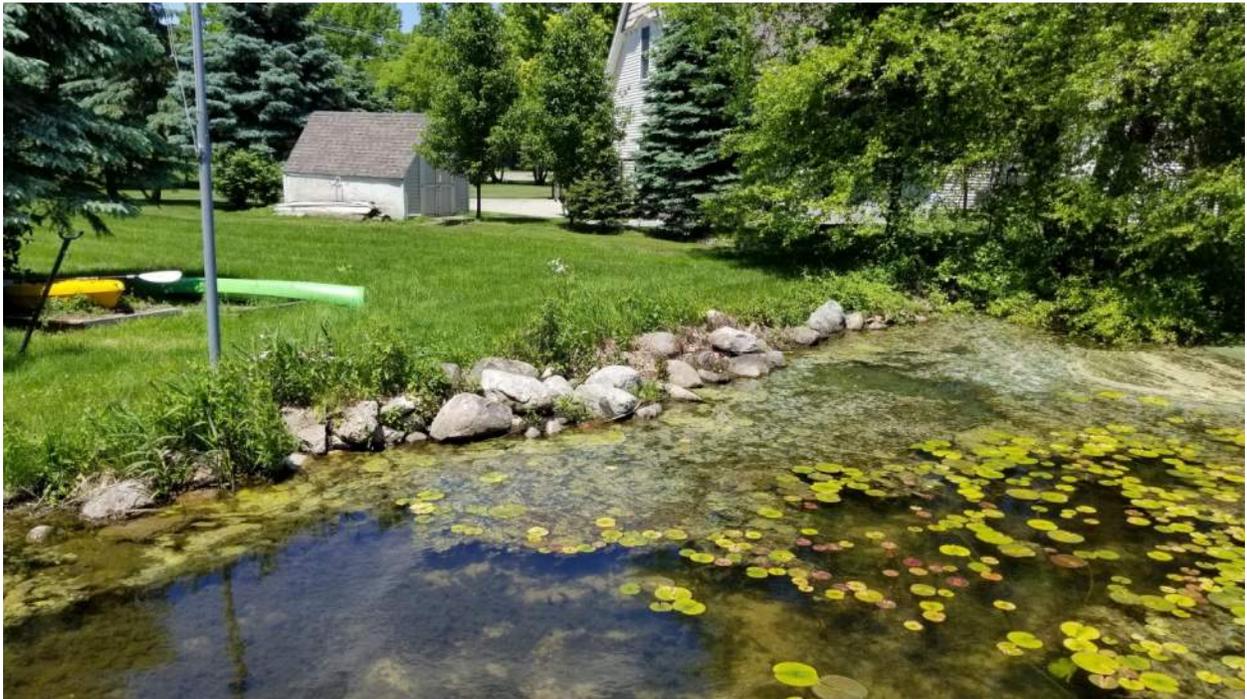
Figure 6 – Riprap Shoreline Right of Spillway from Dock

Figure 6: Shows the riprap shoreline right of the spillway. (June 7th, 2019)

No significant erosion was observed at the time of inspection. It is recommended regular upkeep be done to prevent possible erosion.

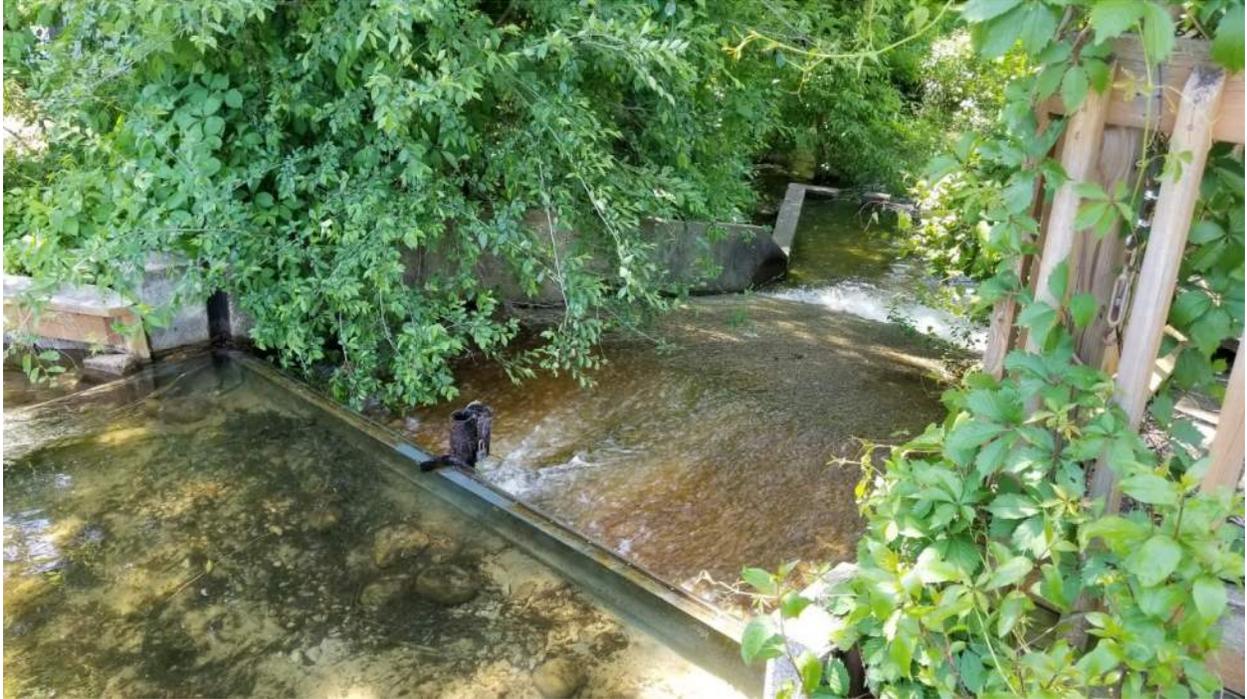
Figure 7 – Spillway

Figure 7: Shows the spillway. (June 7th, 2019)

The spillway and water level control structure are in satisfactory condition with some minor cracks and spalling. The spillway, however, does not allow for fish to pass from the Pine Lake Outlet Drain into Lake Lansing. Modifications could be made to the spillway to allow for fish passage.

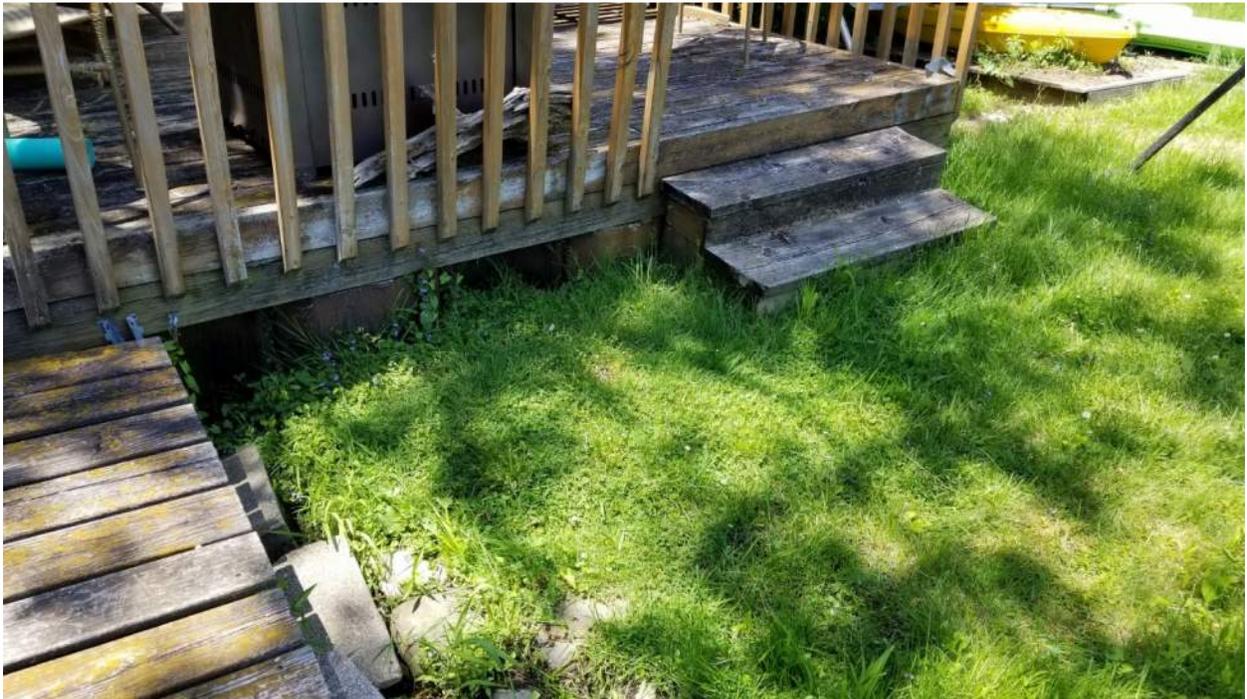
Figure 8 – Sheet Piling Right of Spillway

Figure 8: Shows the sheet piling under the wooden deck. (June 7th, 2019)

The sheet piling has shown some signs of corrosion and needs to be mitigated. Replacement may be an option, but other means could be considered such as restoration and painting of the steel while installing an outside concrete barrier for further protection.

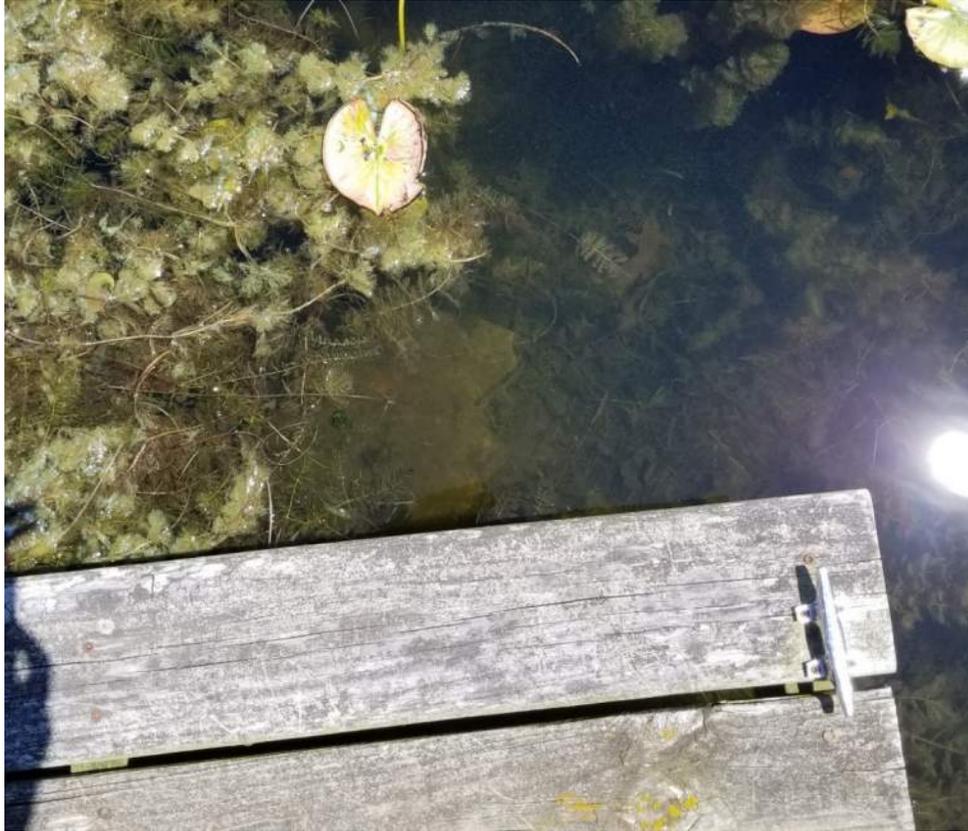
Figure 9 – Intake Pipe at End of Dock

Figure 9: Shows the end of the intake pipe. (June 7th, 2019)

The intake pipe which is located immediately underneath the wooden dock has rusted out and is pitted in many locations along its length. The condition could be observed readily when the valve is operational as bubbles are seen where holes are present. Furthermore, the intake pipe lacks any screens as to prevent fish or debris from washing into the drain.

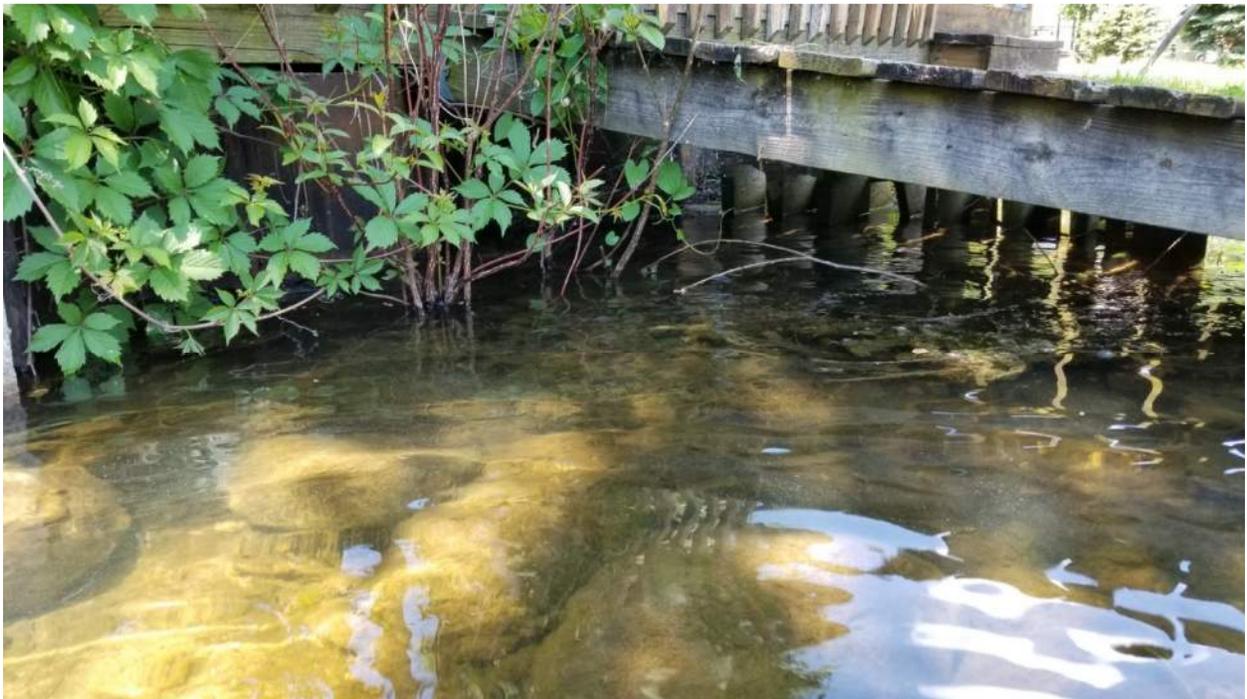
Figure 10 – Intake Pipe Under Dock

Figure 10: Shows some bubbling form the intake pipe underneath the dock. (June 7th, 2019)

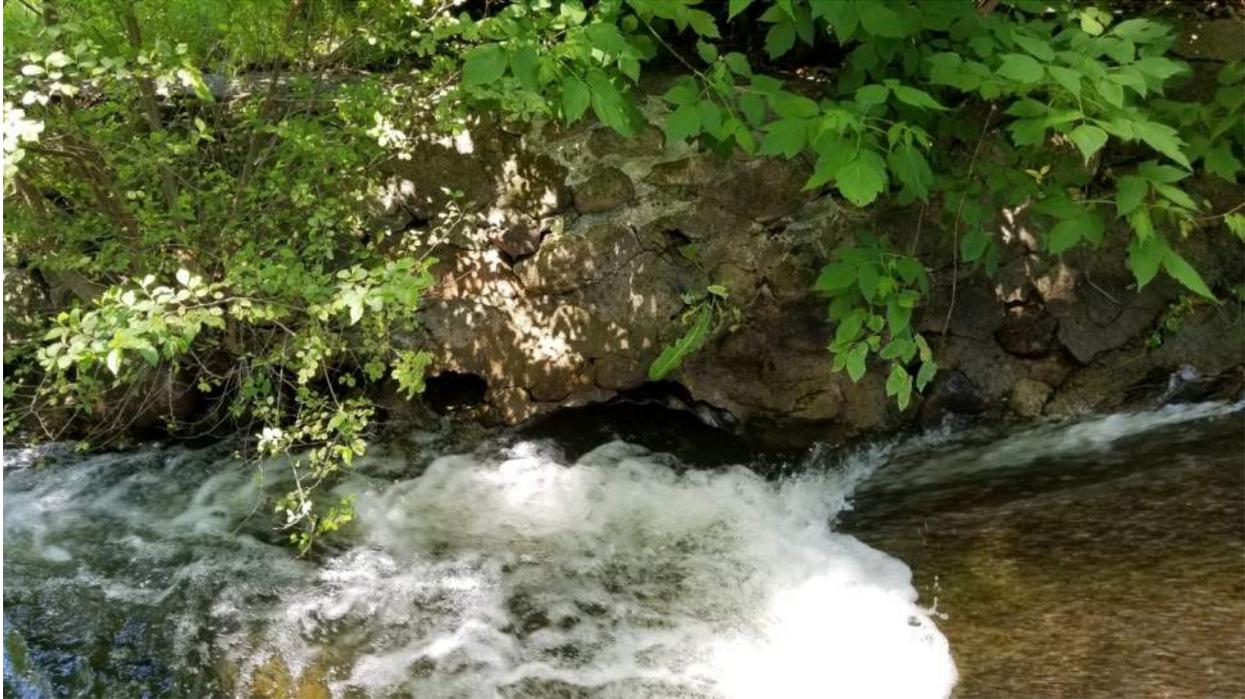
Figure 11 – Bypass Pipe in Spillway

Figure 11: Shows the bypass pipe from the intake structure to the spillway while the valve is open. (June 7th, 2019)

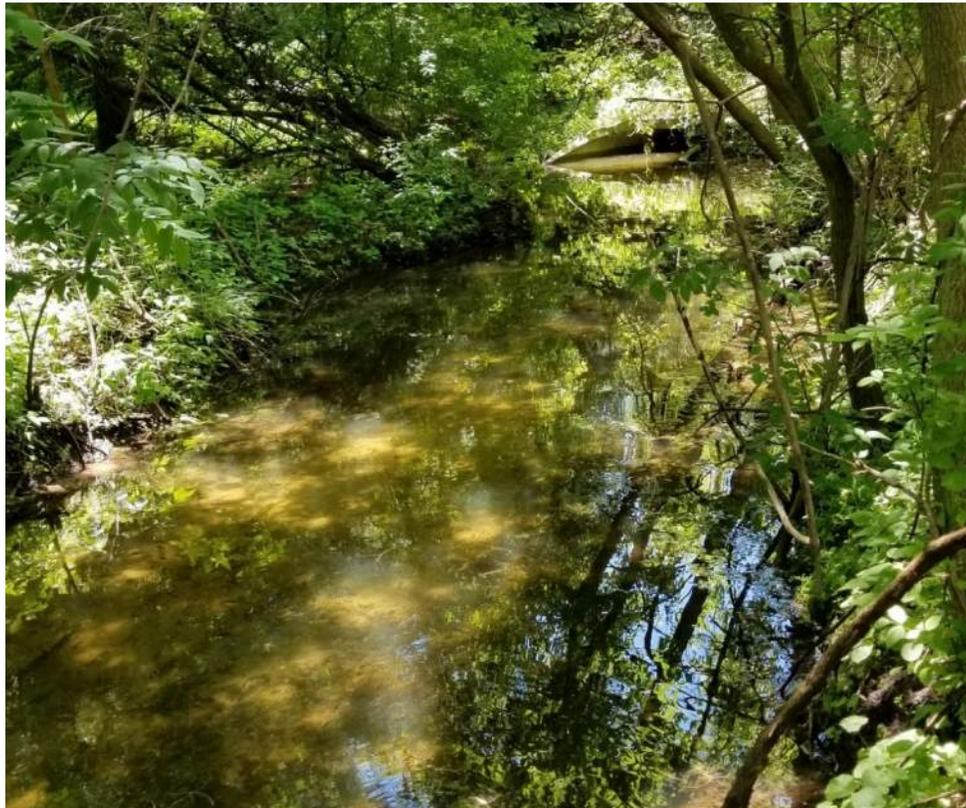
Figure 12 – Open Channel Facing downstream

Figure 12: Shows the open channel looking downstream toward the Marsh Rd. outlet structure. (June 7th, 2019)

The outlet drain is in good condition. Regular clearing and grubbing of vegetation are recommended within the open channel.

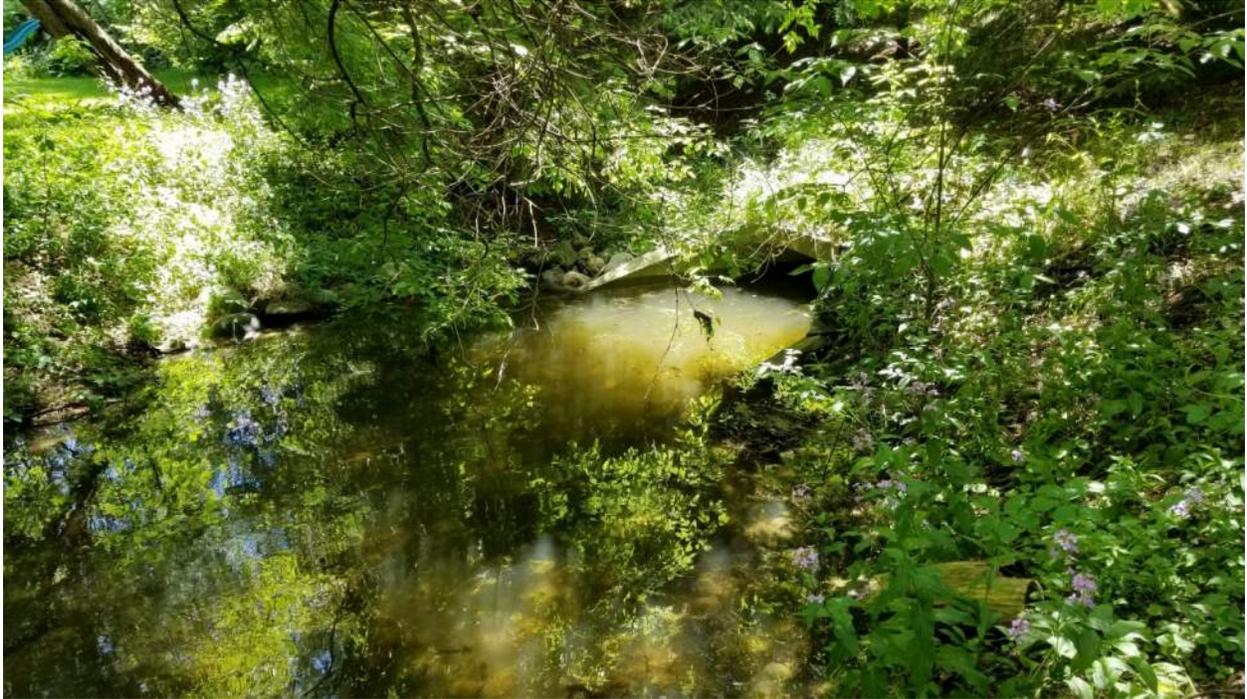
Figure 13 - Marsh Rd. Outlet Structure: East End

Figure 13: Shows the Marsh Rd. outlet structure on the east side of Marsh Rd. (June 7th, 2019)

The outlet culvert is in good condition. Regular clearing and grubbing of vegetation around the outlet culvert are recommended especially along the downstream end of the culvert west of Marsh Road.

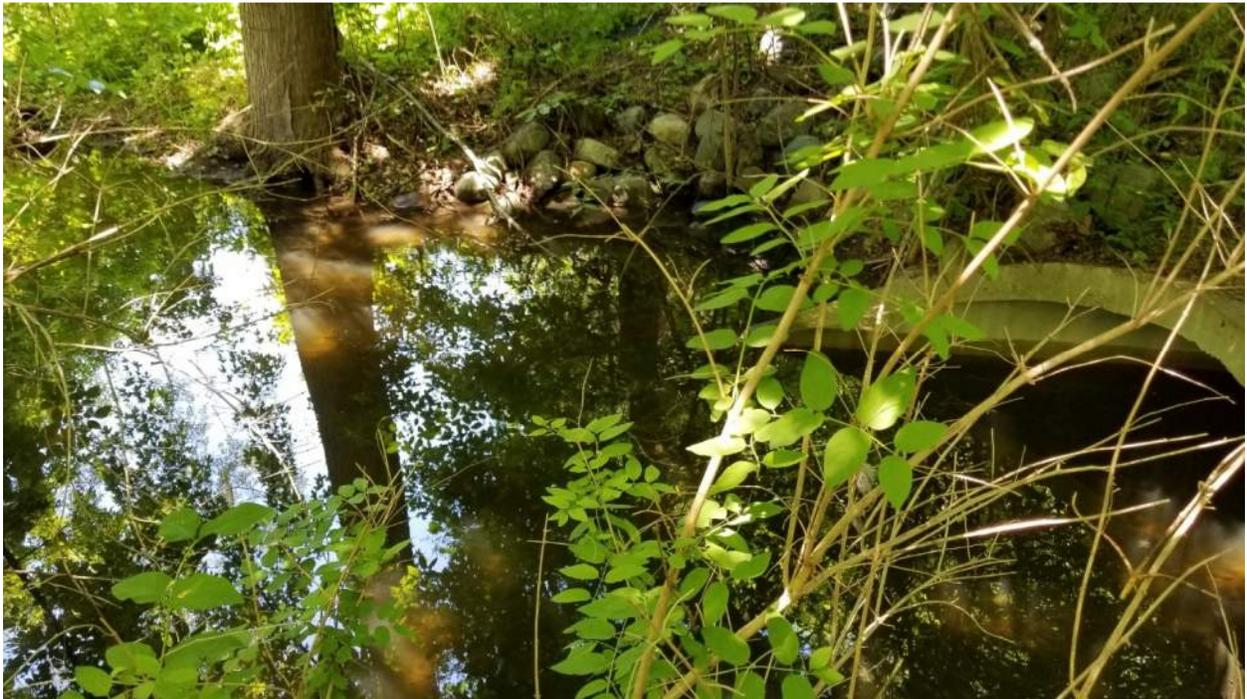
Figure 14 – Marsh Rd. Outlet Structure: West End

Figure 14: Shows the Marsh Rd. outlet structure on the west side of Marsh Rd. (June 7th, 2019)

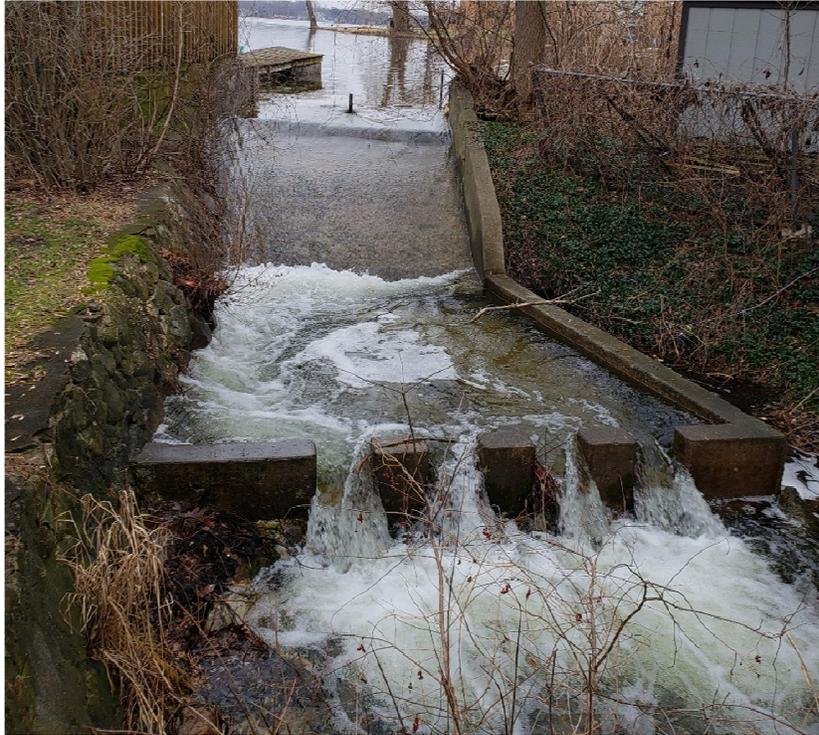
Figure 15 – Still Basin

Figure 15: Shows the concrete stilling basin looking towards the lake. (January 3rd, 2020)

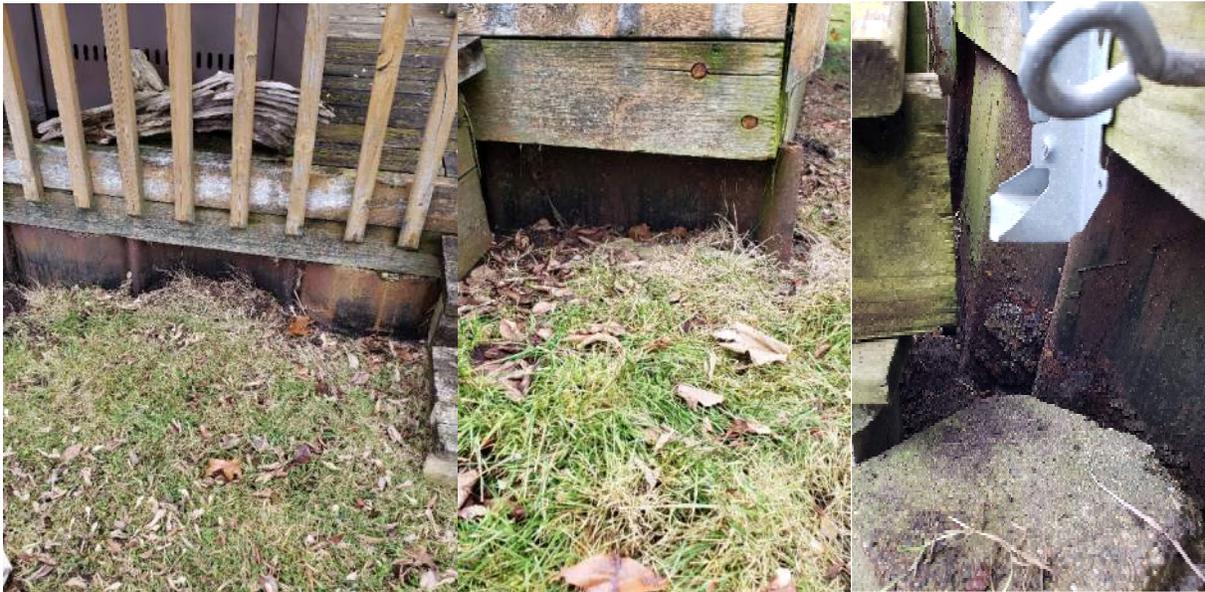
Figure 16 – Sheet Piling

Figure 16: Shows the corrosion of the sheet piling under the wooden deck. (January 3rd, 2020)

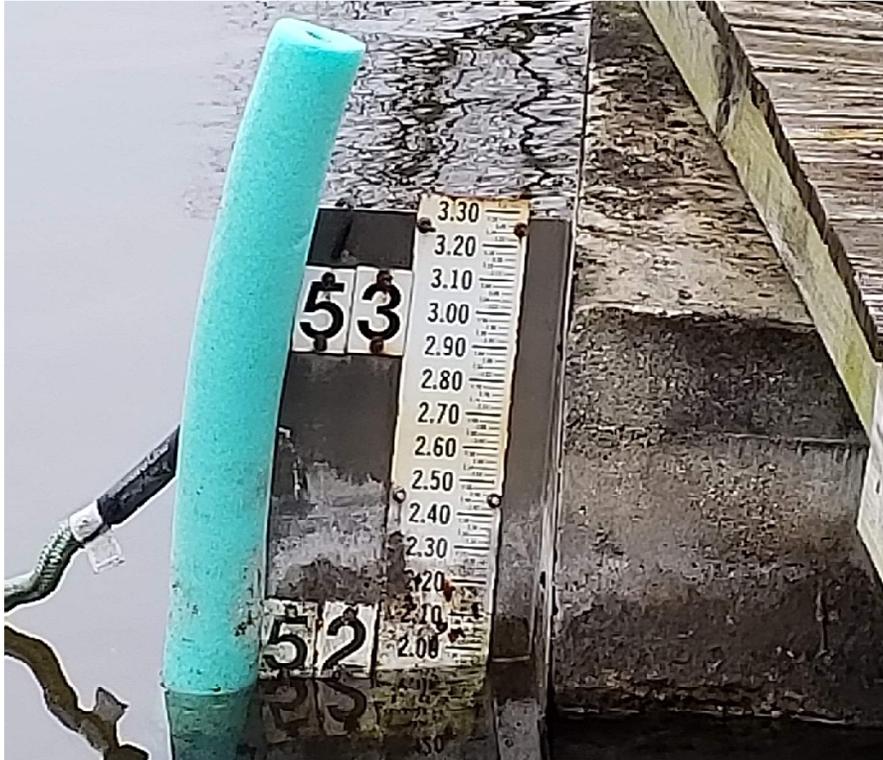
Figure 17 – Water Level

Figure 17: Indicates the water level at the time of the January 3rd inspection.

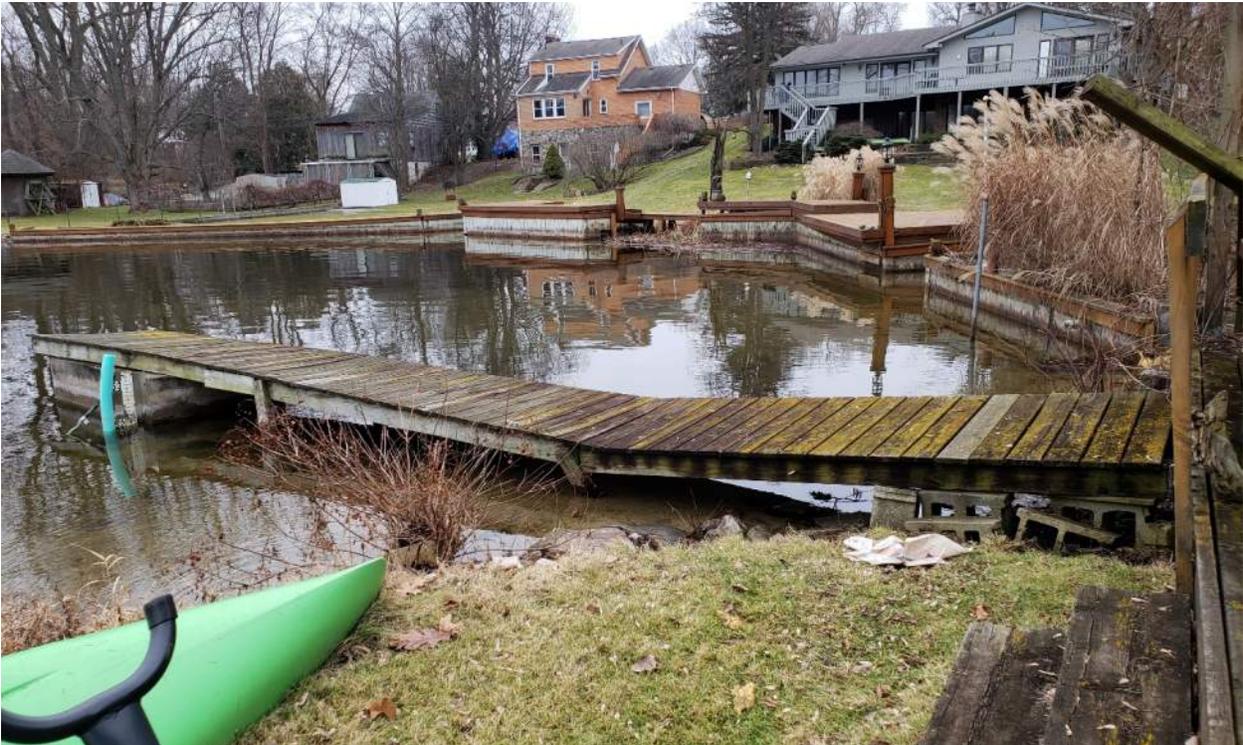
Figure 18 – Wooden Dock

Figure 18: Shows the condition of the wooden dock. (January 3rd, 2020)

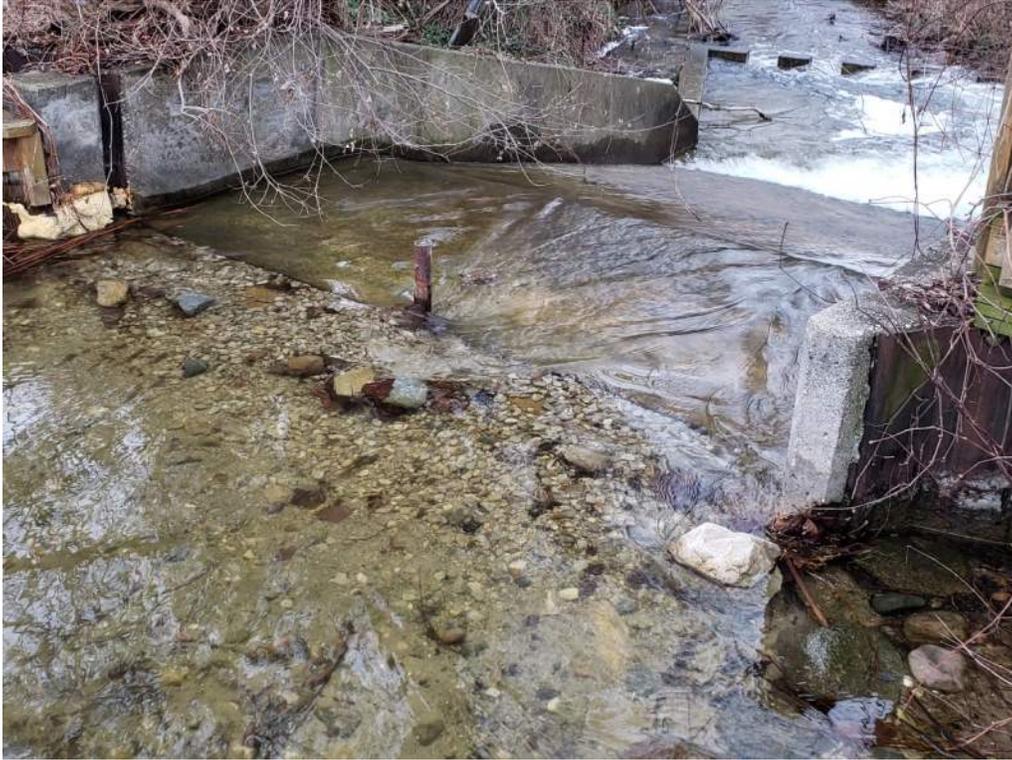
Figure 19 – Spillway

Figure 19: Shows the spillway. (January 3rd, 2020)

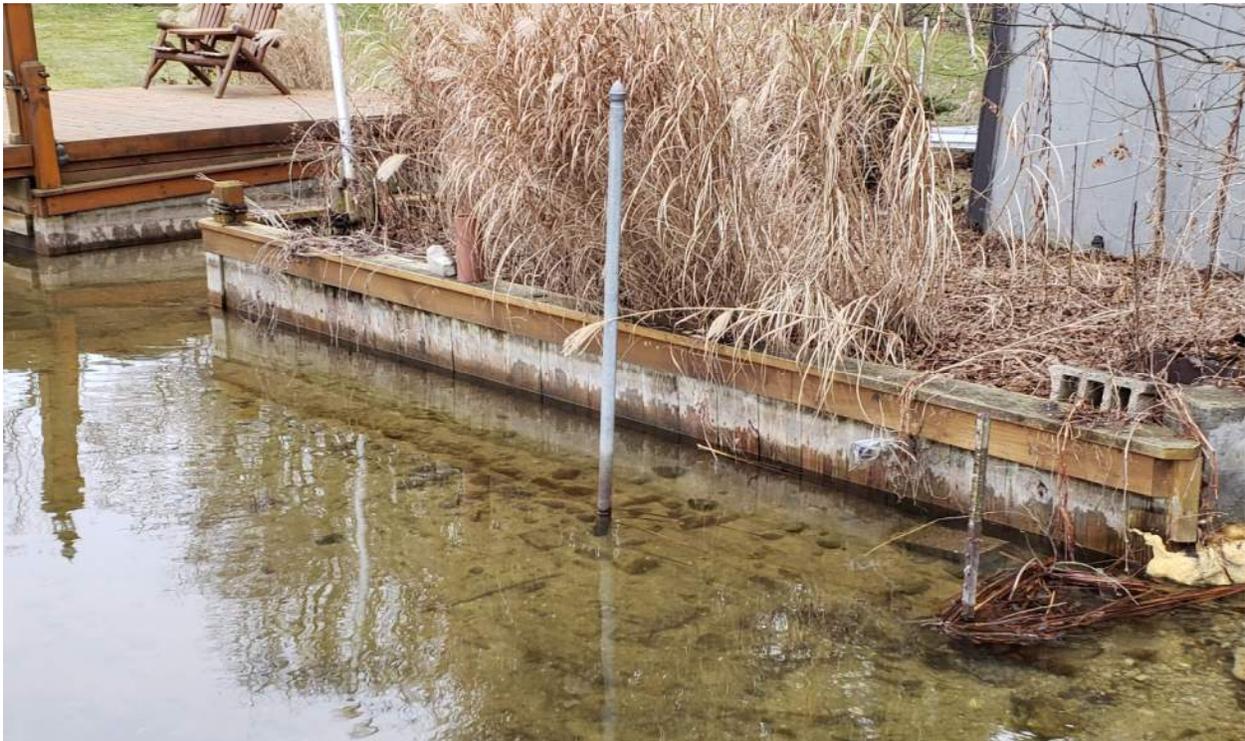
Figure 20 – Seawall Left of Spillway

Figure 20: Shows the seawall left of the spillway from the dock. (January 3rd, 2020)

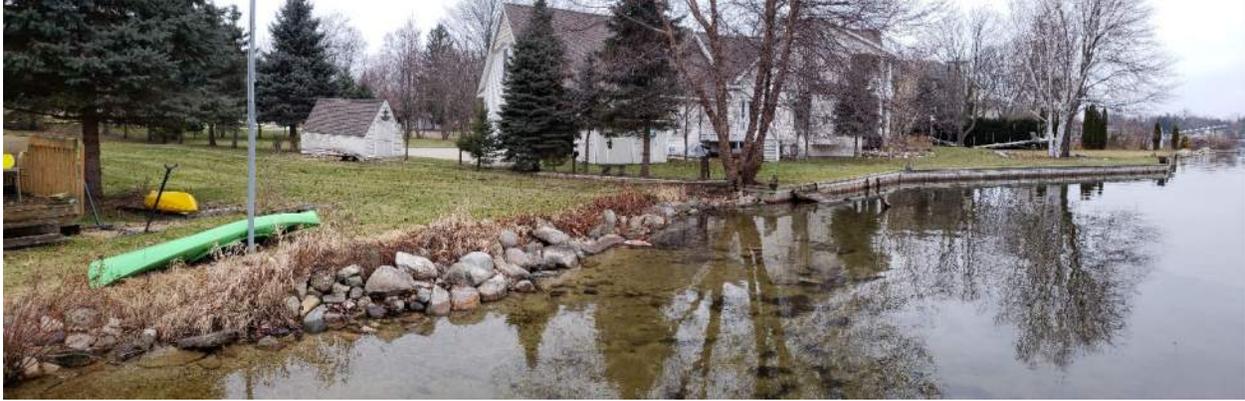
Figure 21 – Riprap Right of Spillway

Figure 21: Shows the riprap shoreline right of the spillway. (January 3rd, 2020)

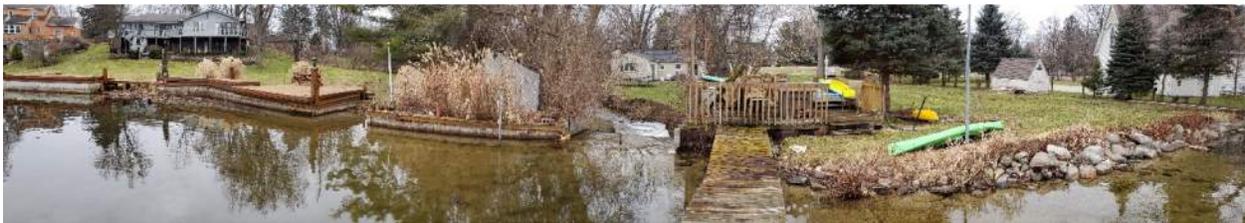
Figure 22 – Panoramic View from Dock

Figure 22: Shows a panoramic view of the dam from the dock. (January 3rd, 2020)

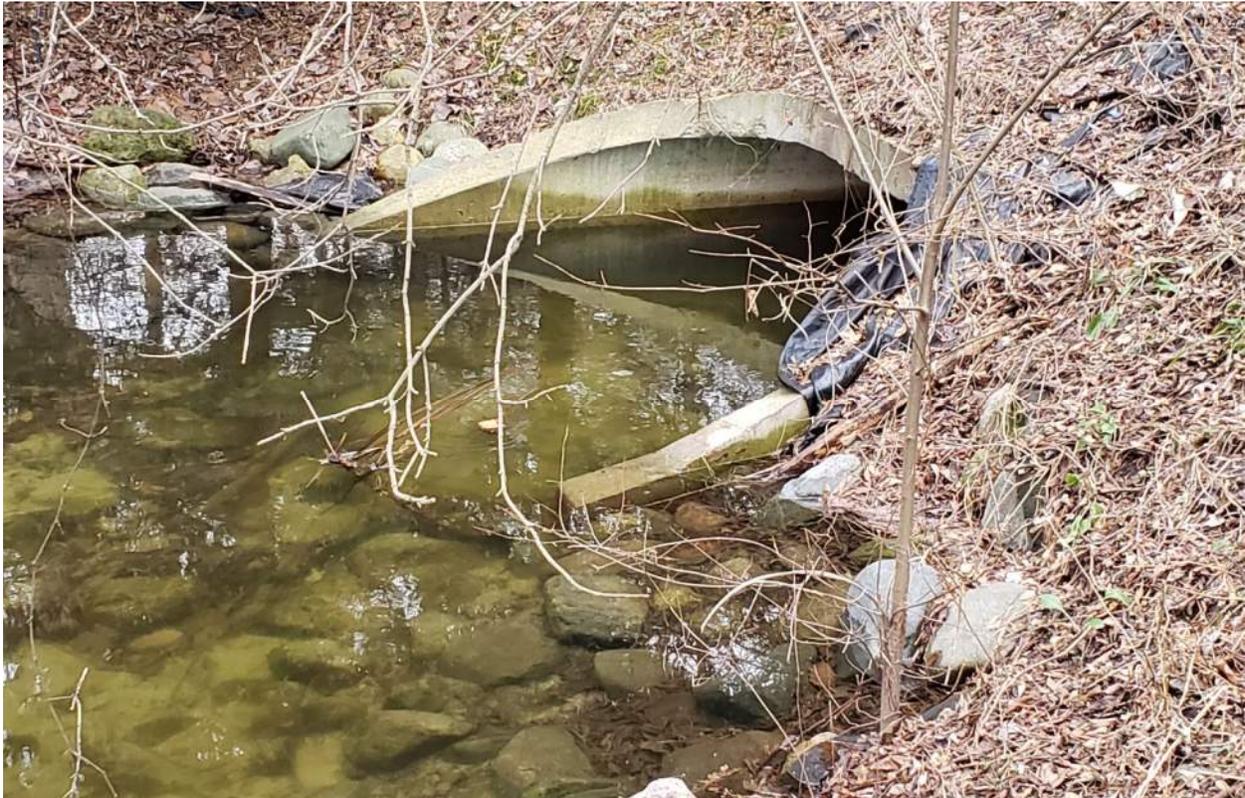
Figure 23 – Marsh Rd. Outlet Structure: East End

Figure 23: Shows the Marsh Rd. outlet structure on the east side of Marsh Rd. (January 3rd, 2020)

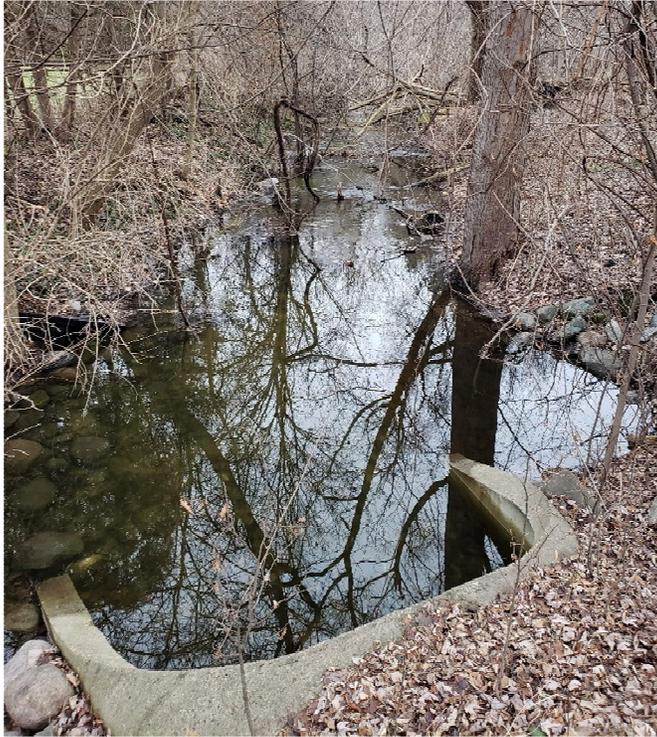
Figure 24 – Marsh Rd. Outlet Structure: West End

Figure 24: Shows the Marsh Rd. outlet structure on the west side of Marsh Rd. (January 3rd, 2020)

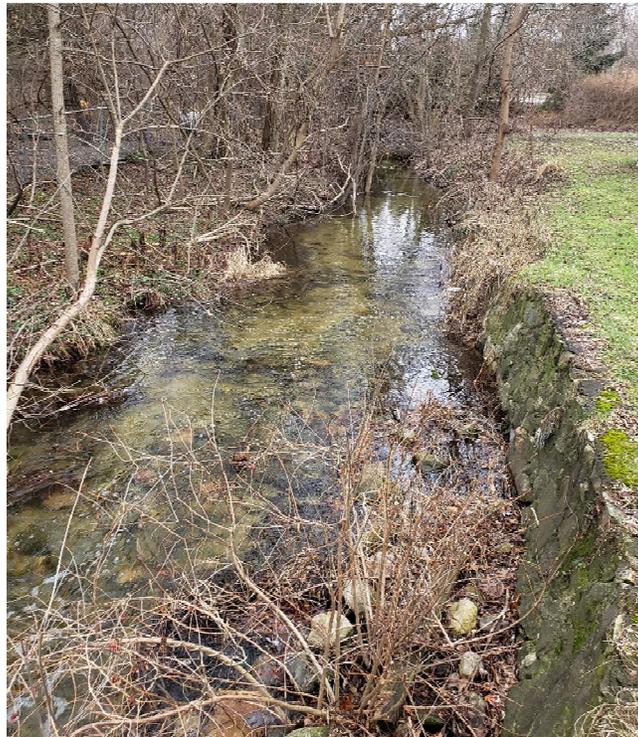
Figure 25 – Open Drain Facing Downstream from Still Basin

Figure 25: Shows the open channel facing downstream from the still basin. (January 3rd, 2020)
