LAKE LANSING DAM INSPECTION REPORT

Dam Identification No. 1957
Meridian Township, Ingham County, Michigan

12/29/2025

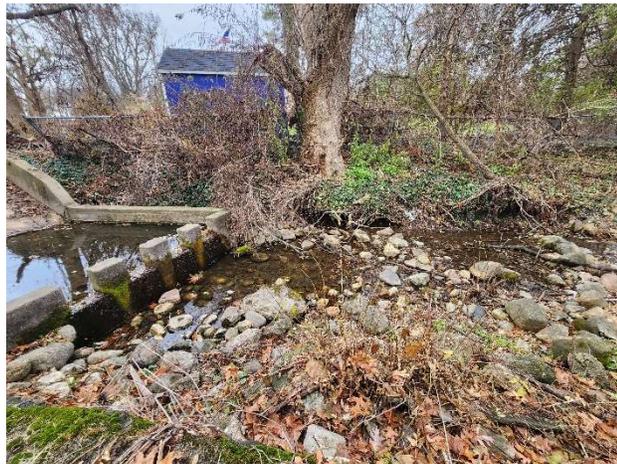
The outlet drain is in good condition. Regular clearing and grubbing of vegetation are recommended within the open channel to remove obstructions. **The tree along one side of the spillway is being undermined and will need to be removed and area repaired.**
